TEST OF A MICRO-CONCRETE MODEL OF A BUILDING DAMAGED DURING THE 1985 CHILE EARTHQUAKE

R. TOBAR and P. BONELLI

Universidad Técnica Federico Santa María
Casilla 110-V, Valparaíso, Chile.

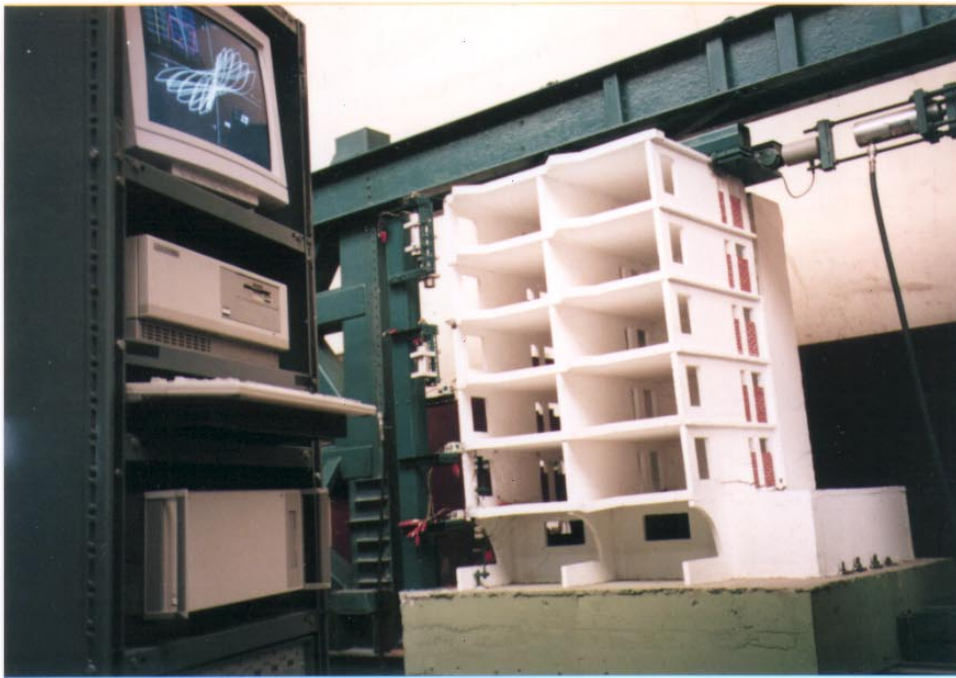
Fig. 2 1:10 scale building model

The 1:10 scale micro-concrete model (Fig. 2) was intended to reproduce, in a simplified way, the complete structure, taking a special care to reproduce the M-axis wall and surrounding areas. The objective of this work was to study the three-dimensional behavior of the structure, especially the effect of the rest of the elements on the critical M-axis wall.

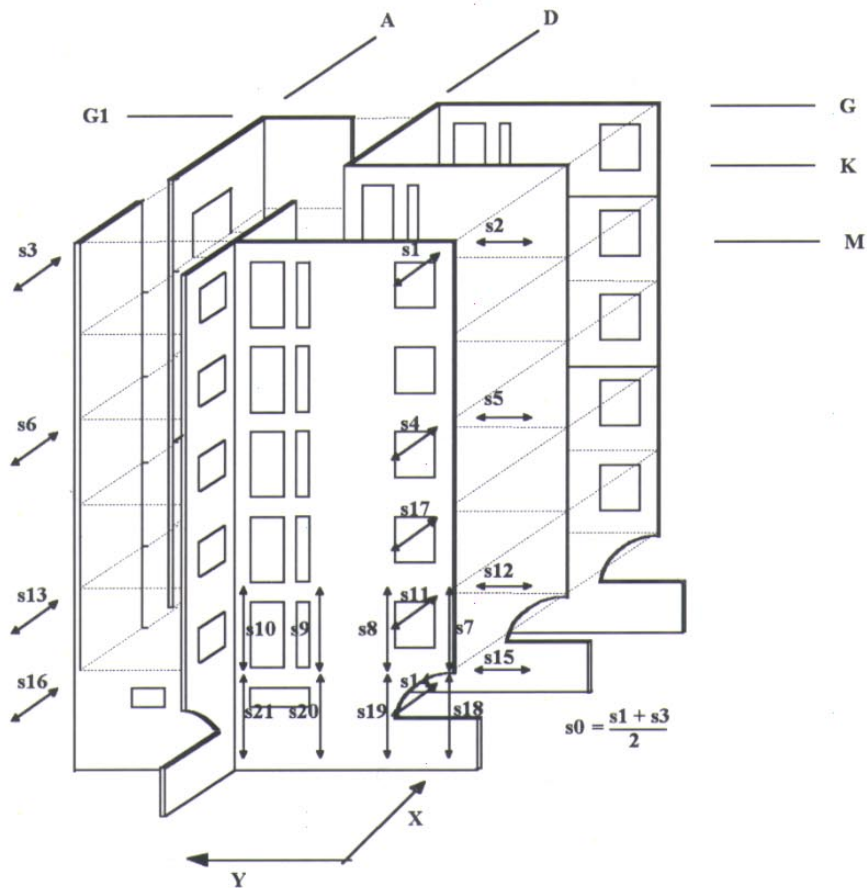
On the other hand, the axial forces on the M-axis wall induced by the building overturning moment, reached their maximum level when the building was being loaded in the direction transverse to the wall. Since the objective was to study the most critical conditions for this wall, the building model was loaded in the X-direction during the test (Fig. 3).

Fig. 3 General view of the 3-D building model showing the location of the displacement transducers
