DETAILED ANALYSES OF STEEL AND REINFORCED CONCRETE BUILDINGS DAMAGED BY THE 2003 BAM EARTHQUAKE IN IRAN

N. Hosseinzadeh

Assistant Professor, Dept. of Structural Engineering, International Institute of Earthquake Engineering and Seismology (IIEES), Tehran, Iran, Email: hosseinz@iiees.ac.ir

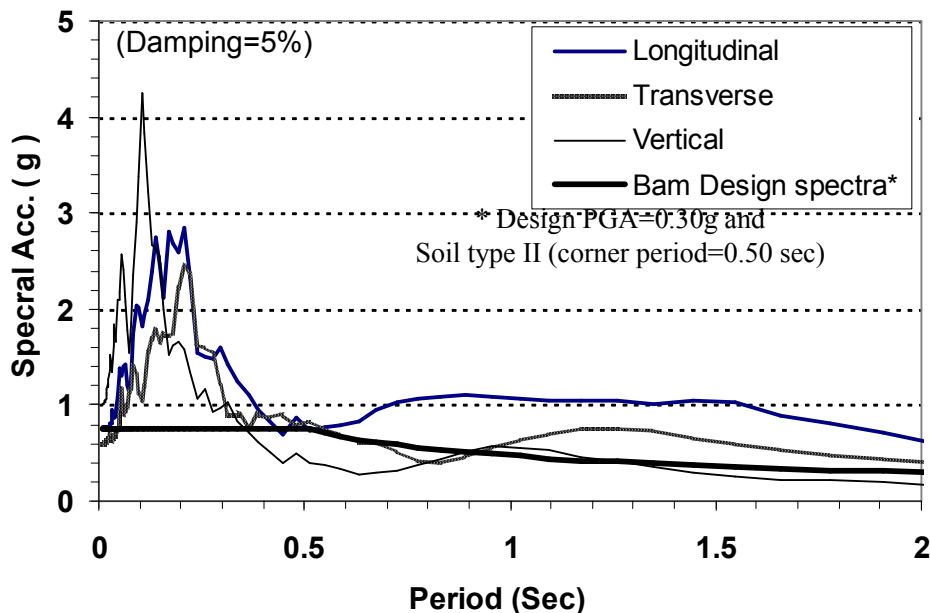
Figure 1 Spectral accelerations of Bam earthquake and Bam design spectra

It is clear from spectral accelerations that the dominant period of the ground motion in horizontal and vertical directions are about 0.2 sec and 0.1 sec, respectively. The maximum spectral accelerations at these periods are 2.85g and 4.25g respectively. Also, the acceleration amplifications at these periods are about 4.0 for both horizontal and vertical components. This value is 1.6 times greater than the Iranian seismic code design requirements [6].

Comparison between response spectra of Bam earthquake and Bam design spectra shows that the recorded event is greater than the design values (see Figure 1). For example, the spectral acceleration of horizontal component in dominant period (0.2 sec.) is about four times greater than the design value. This means that the lateral seismic loads in elastic range based on Iranian seismic code is lower than those implied by Bam earthquake, especially in low rise buildings.

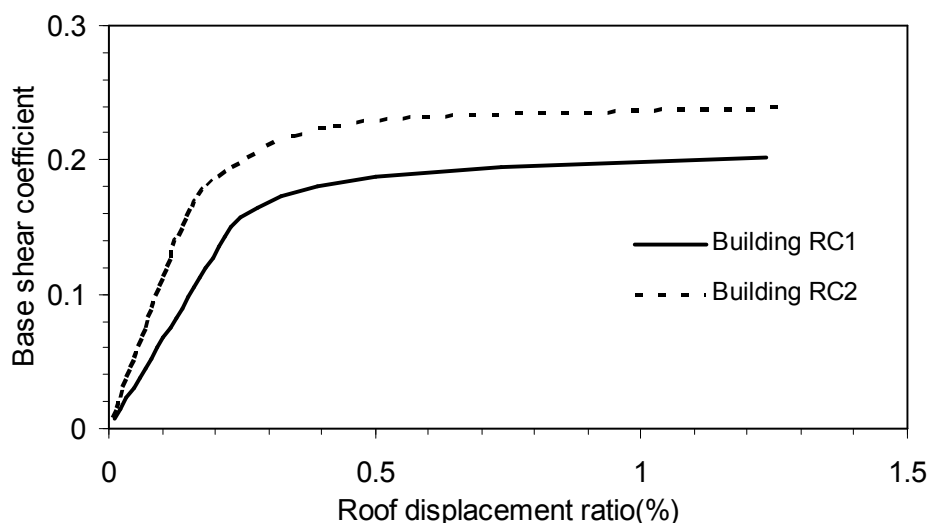
The main seismic parameters and the results of base shear coefficients (C , C_e , and C_y) determined for the example buildings are summarized in Table 2. The results of nonlinear pushover analyses are shown in Figure 7 for R.C. buildings for example.

Figure 7 Push over curves of R.C. sample buildings

One important result has been obtained by comparing C and C_e , as determined for the example buildings. Generally, the earthquake demand is greater than the code required base shears in the case of ordinary studied buildings with low dominant periods ($C_e \geq C$). This result is similar for R.C. and steel buildings.
