LESSONS LEARNED FROM YOGYA AND ACEH RECOVERY PROGRAM

Made Suarjana¹ and I Wayan Sengara²

^{1,2} *Civil Engineering Dept. and Center for Disaster Mitigation, Institut Teknologi Bandung, Indonesia
Email:msuarjana@si.itb.ac.id*

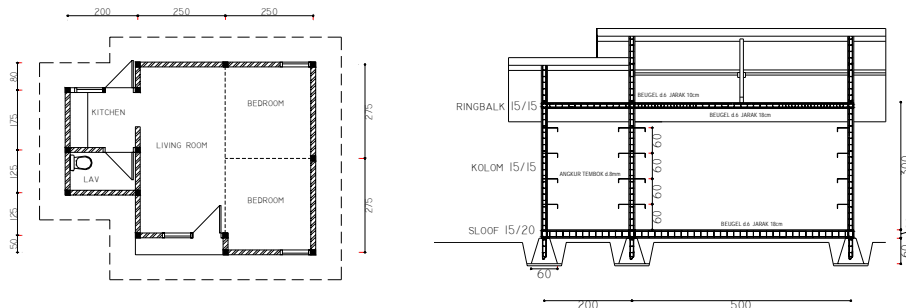
Figure 1. Plan view and section of the original housing design

The analysis by FEM program for two house type in Aceh and one in Yogya showed the following vulnerabilities and strength deficiencies:

- Torsional vibration modes induce high stress to members around the reentrant corners. Some beams and columns shown to be overstressed due to design earthquake load.
- Overstressed structural members due to incomplete foundation system in some of Aceh house designs.

- Due to assumption that the internal walls will be constructed in the future, the current configuration has wide wall and frame system that has out of plane support system too far apart (6 to 7 meters). The analysis shows that the wide wall and frame system has inadequate strength in the out of plane direction.
- Gable frames are not properly supported in the out of plane direction (by perpendicular concrete beam at the top or bracing system). The concrete frame dimensions for the gable are not specified, so sometimes smaller concrete members (10x10 cm²) are used. The analysis shows gable frames strength are inadequate.
