OBSERVED BEHAVIOUR OF EARTHEN STRUCTURES DURING THE PISCO (PERU) EARTHQUAKE OF AUGUST 15, 2007

M. Blondet¹, J. Vargas² and N. Tarque³

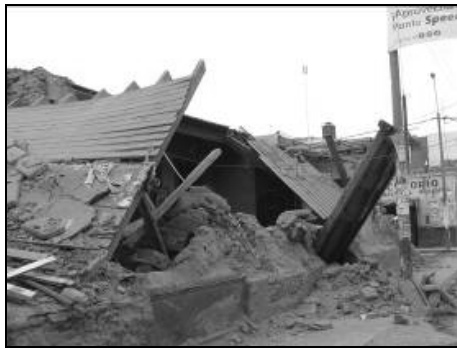
Figure 3 Old adobe dwellings in Ica.

The older adobe dwellings surrounding Ica's main square have a 0,8 m high plinth wall made with fired clay bricks (Figure 3a) to protect the walls from the humidity in the area, as Ica has already suffered several floods in the past. The completed wall is usually 4 m. high and 0,8 m thick. Eucalyptus trunks are sometimes placed within walls to partially bear the roof's weight (Figure 3b). The roofs of these constructions are built using a of wooden joists framework covered with a first layer of crushed cane, a second layer of straw mats (*esteras*) and finally plastered with mud. The wooden joists can either be parallel or perpendicular to the façade walls.

a) Plinth wall made using clay bricks

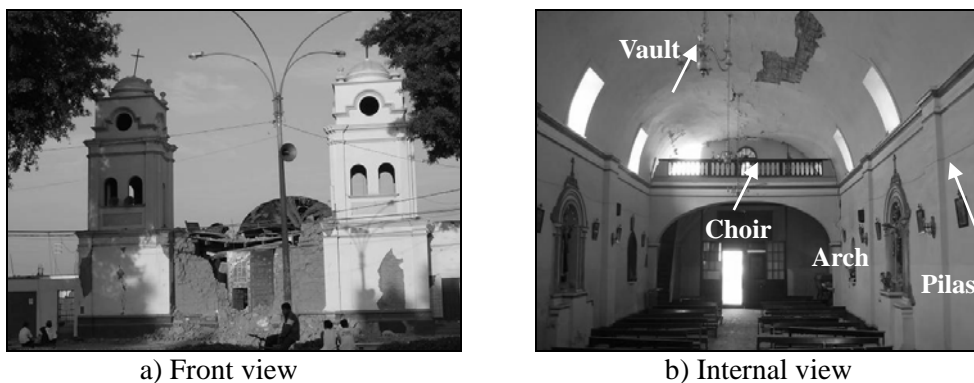
Figure 10 Typical earthen churches.

Almost all of the churches and historical landmarks that had been built with soil and bricks suffered heavy damage or even collapsed as a consequence of the earthquake. According to the National Institute of Culture (INC), 32% of the historical and cultural monuments in Ica have completely collapsed, 23% are under strong risk of collapsing, 26% are under moderate risk and 19% show minor damage to their structure (24 Horas Libres, 2007). Most of the earthen churches in Ica have one or two towers that are about 3 to 4 story high as part of their façade, lateral adobe walls (1,20 m thick and 5 to 6 m high approximately), and a roof consisting of a cylindrical vault constructed using wooden arches, crushed cane, straw mats and a mud coat on the outside and stucco on the inside (Figure 10). The plan view of the church is cross-shaped. The choir area (which is 2-story high) is located right behind the church's main door and the altar is on the back of the church. The church's lateral walls have pilasters built approximately every 4 m that simulate columns (Figure 10b).
