Damaging Effects of the Pisco-Chincha (Peru) Earthquake on an Irregular RC Building

O. Kwon

ABSTRACT :

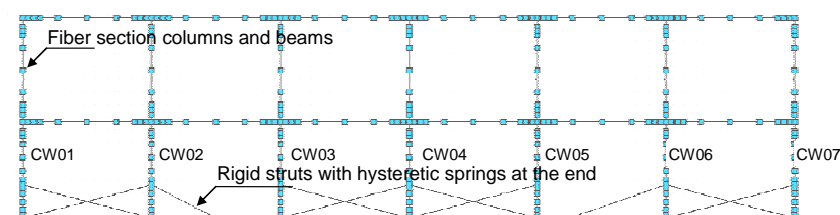
Figure 4. Analytical Model of a Reference Frame

The shaded frame on the west module of the building in Figure 1 is modeled for numerical analyses. The analytical model has six bays and two stories, Figure 4. Infill walls are modeled as diagonal struts whose hysteretic properties are discussed in the later part of this section. The material properties of the concrete and steel reinforcements were not obtained from the field investigation. The strengths of concrete and steel reinforcements are assumed based on typical material properties. Concrete ultimate strength is assumed to be 27 MPa and steel yield strength is assumed to be 410 MPa. Dimensions of column and beam sections were obtained from the field. Field measurements of the diameters and number of longitudinal and transverse reinforcements of columns were obtained and are shown in Figure 5. Sections of beams are modeled as T-beams to account for the effect of slabs. The effective flange width is assumed to be the smallest of 1/4 of beam length (2000 mm), 16 times the slab thickness (4000 mm), and a clear distance from web to adjacent web (4200 mm) as proposed in ACI 2002. The reinforcements of beams were not obtained from the field as none of them were exposed. Thus the reinforcements are determined from designing of the T-beam under gravity load. It can be easily noted that the section size of the beam is substantially larger than that of columns. Figure 5 illustrates layout of sections and reinforcements of beams and columns.

Note: Analytical model represents shaded frame in Figure 1.

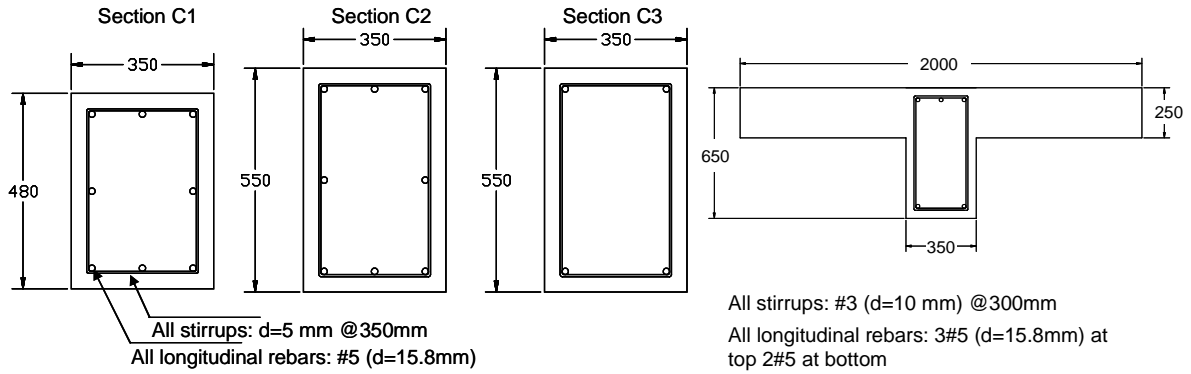
Section C1: CW21, CW22, CW23, CE21, CE22, CE23

Section C2: CW01~08, CW14~20, CE01~08, CE14~20

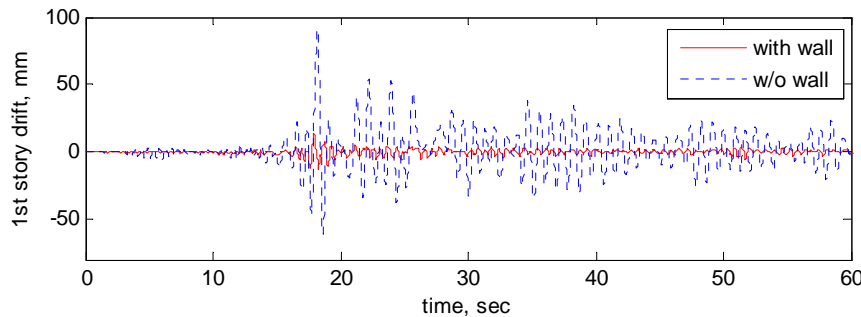
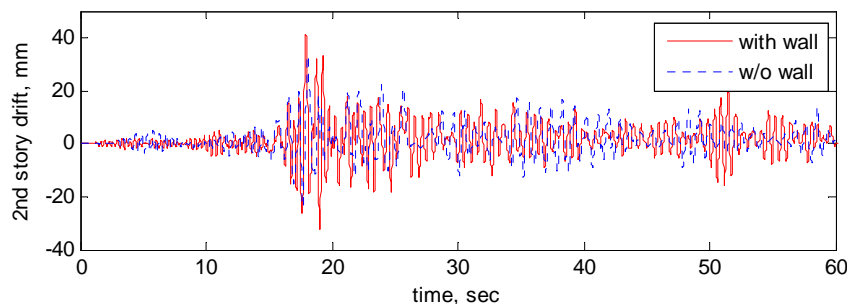
Figure 6. Interstory Drifts From Nonlinear Response History Analysis

The fundamental periods of the two frames, one without infill walls and the other with infill walls, are 0.26 sec and 0.37 sec from Eigen value analysis. Nonlinear response history analyses are conducted with both structures. The E-W component of the recorded ground motion at ICA2 station, is applied to the frame. The ground motion is not scaled. The frame without infill wall experiences much larger interstory drift at the first floor than the interstory drift of frame with infill wall, Figure 6. Shear force demands on the first story columns are compared in Table 1. Note that shear force demands on the frame with infill wall is up to 50% higher than the demands on the frame without infill wall. The shear capacity of the column is calculated following ACI design guidelines, ACI 318-02. In the shear capacity calculation, the contribution of stirrups is ignored as the stirrups were very widely spaced and smooth wires with diameters of 5 mm or less are used in the construction. Shear capacity provided by concrete for the Column CW06 is based on following equation in design code.

From Table 1, it can be noted that the shear force demands to columns of the frame with infill walls are close to 50% larger than those to columns without infill walls. Also the seismic demand is very close to the shear capacity, 149 kN, calculated with design shear equation.

(a) First story interstory drift

(b) Second story interstory drift
