## IDENTIFICATION OF LIQUEFACTION FAILURES BASED ON AERIAL IMAGES

J.A. Buchheister<sup>1</sup> and M. Rezaeian<sup>2</sup>

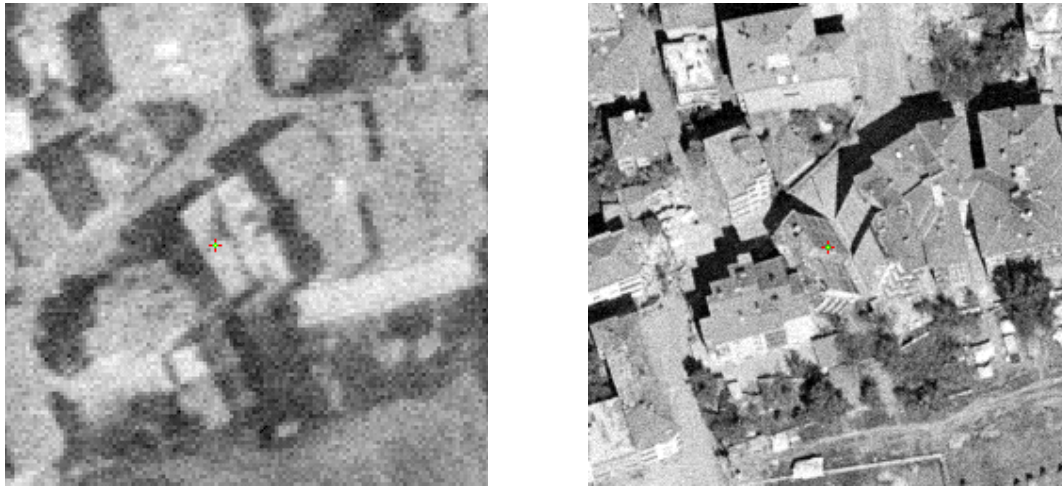
(a) Before the earthquake

(b) After the earthquake

Figure 2: Two pairs of aerial images before (1994) and after (1999) of Adapazari earthquake –Turkey (Scale 1: 35000 & 1:18000 Grayscale image)
