Strategy for Earthquake Disaster Preparedness Design based on Structural Assessment and Geohazard Vulnerability Map

Pundong and Imogiri in Bantul, Yogyakarta, Indonesia as Study Areas

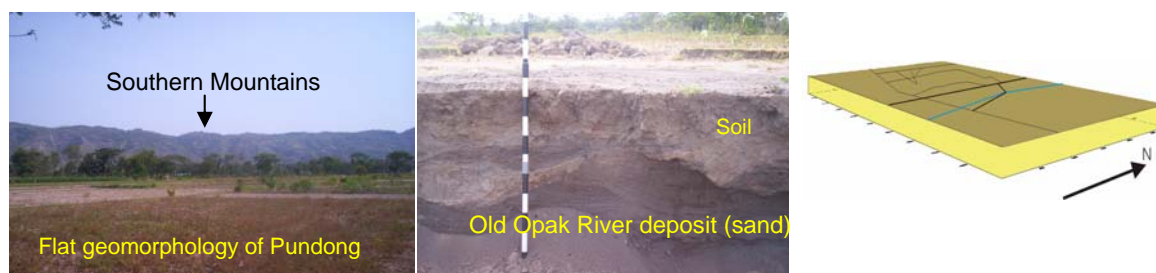
Panjangrejo Village is located in Pundong on the west of Opak River and to the east is also bordered by west slope of Southern Mountains. Geomorphologically this area is very flat, the height difference is less than 5 m. The area is covered by thin soil (regosol, approximately only 20 – 40 cm) with sandy-clay size (see Figure 2). The soil lay above the old-Opak river sediment which dominantly consists of loose fine to coarse sand. No manifestations of geological structure are found in this area. If there any structures occur, they are probably on the bedrock in subsurface and already covered by recent surface sediment of old-Opak River and soil.

Figure 2. Illustration of flat morphology and thin soil above loose sand deposit in Panjangrejo Village, Pundong area.
