REPAIRING OF SHEAR-DAMAGED RC JOINT PANEL ZONE USING CHEMICAL EPOXY INJECTION METHODOLOGY

O. Kaya¹, C. Yalcin², A. Parvin³ and S. Altay⁴

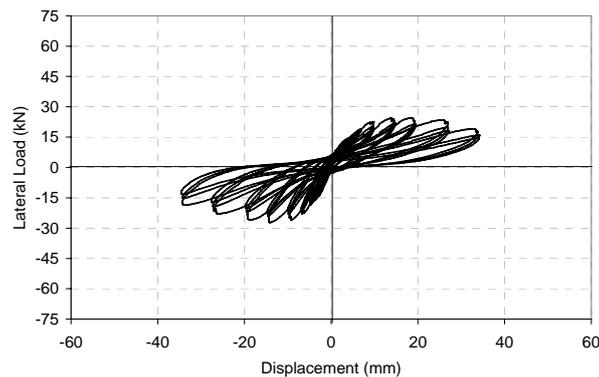
Figure 4.2 Force – displacement relationship of the control specimen

After the 0.50% drift level, more visible damages were observed at joint region. At the drift level of 0.75%, the maximum loads observed in pull and push directions were 27 kN and 24 kN, respectively.

In the subsequent drift cycles, up to the 1.75% drift level, additional shear cracks occurred at the joint region and load carrying capacity started to decrease. When the drift level of 1.75% was applied, the column longitudinal reinforcements started to buckle, and thus, the cover concrete at the back side of the joint totally spalled off. At the same time, the diagonal cracks widened. The test ended due to the load carrying capacity of the specimen decreased below 80% of maximum load. In Figure 4.1, the crack pattern at end of the tests could be observed. Also, force – displacement relationship of this test is provided in Figure 4.2.

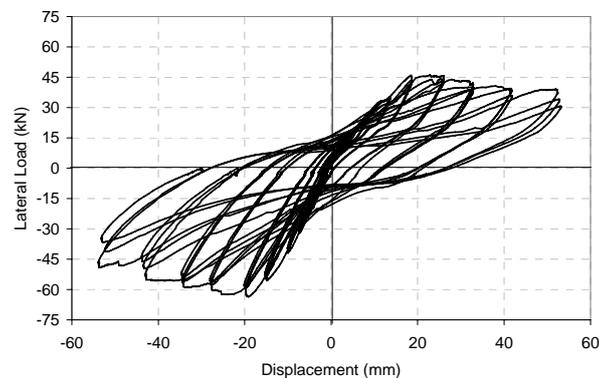
Figure 4.4 Force – displacement relationship of the repaired specimen

During the 1.00% drift cycles, the first diagonal crack occurred at the top corner of the beam-column joint region. The recorded loads were 45.3 kN and 63.2 kN for push and pull directions, respectively. After this drift level, the load carrying capacities started to decrease. The first crack on the bam widened further to about 2.5 mm at the drift level of 1.40%. During this drift level, the vertical cracks were observed at the back side of the column at joint region. The reason of these cracks was due to buckling of column longitudinal reinforcements.

The test was ended at 2.75% drift level when the cover concrete at the back side of the column spalled off completely and the column longitudinal reinforcing bars were buckled. Figure 4.3 shows the observed damage and Figure 4.4 illustrates the force – displacement relationship.

Repair procedure was performed to the already-damaged control specimen. Loose concrete was removed, the surface and the cracks were cleaned using wire brush, and then blown by high-pressure air until the area is free from dust particles. Epoxy injection procedure was started first and several holes were drilled and check valve nipples were placed along the cracks. Large visible cracks were filled with epoxy-based high strength repairing material, *Concresive 1495*, with a compressive strength of 90 MPa. Then, to replace the loose concrete voids, the

joint region is covered with epoxy based material, *Concresive 1406* and a cement-based repairing material, *Emaco S88C*. After the cure of the material, low viscosity *Concresive 1302* epoxy was injected with 200-bar pressure through the nipples via special pumps. The repair material properties could be obtained from BASF material catalogue. An illustration of step-by-step repairing technique is shown in Figure 3.1.
