SEISMIC DAMAGE TO STONE STRUCTURES IN MACHU PICCHU

C. H. Cuadra¹, K. Tokeshi² and J. G. Rojas³

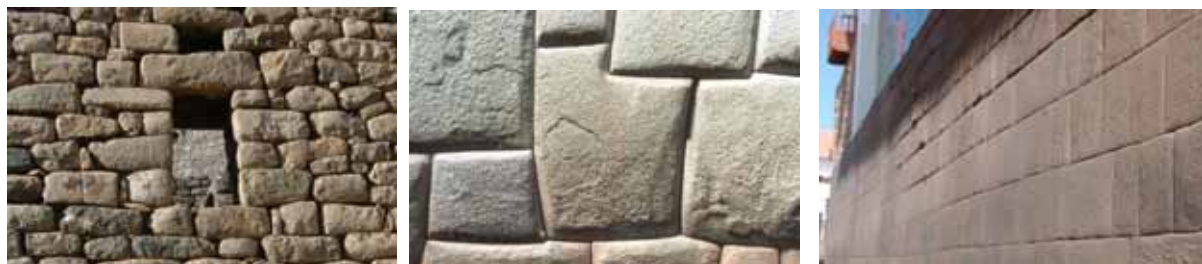
Figure 1. Types of Inca stone masonry

Three types of stone masonry can be distinguished in the Inca stonework, as shown in Figure 1. The first style is a roughly shaped stone fitted with mud mortar, as shown in Figure 1(a). The second style is a finely shaped masonry with polygonal units fitted without mortar, as shown in Figure 1(b). The third style is a finely shaped masonry of rectangular blocks forming horizontal layers as shown in Figure 1(c).

(a) Roughly shaped stone

(b) Polygonal masonry

(c) Rectangular masonry

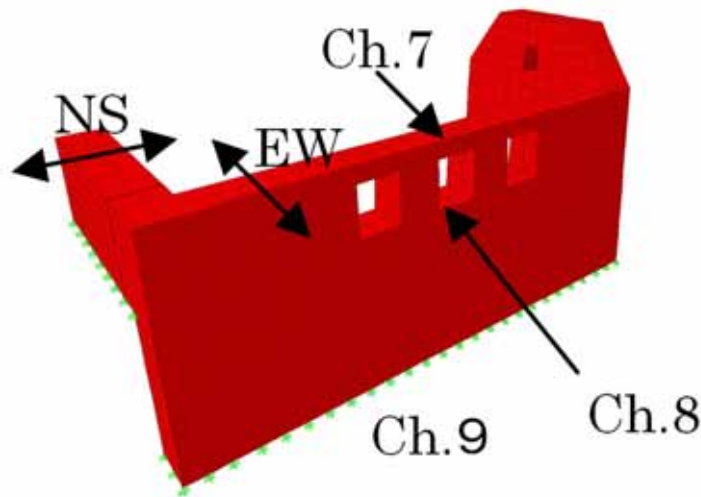
Figure 5. Micro vibration measurements at the Temple of Three Windows

In the case of the Temple of the Three Windows, two horizontal components in NS direction and EW direction were measured, separately. Two sensors were located at the ground near building; one at the external ground (Ch. 9) and another sensor at the inner ground (Ch. 6) of the building. Also, one sensor was located at the central window (Ch. 8) and another sensor at the top of the building (just above the central window) (Ch 7). Figure 5 displays the locations of observation points.

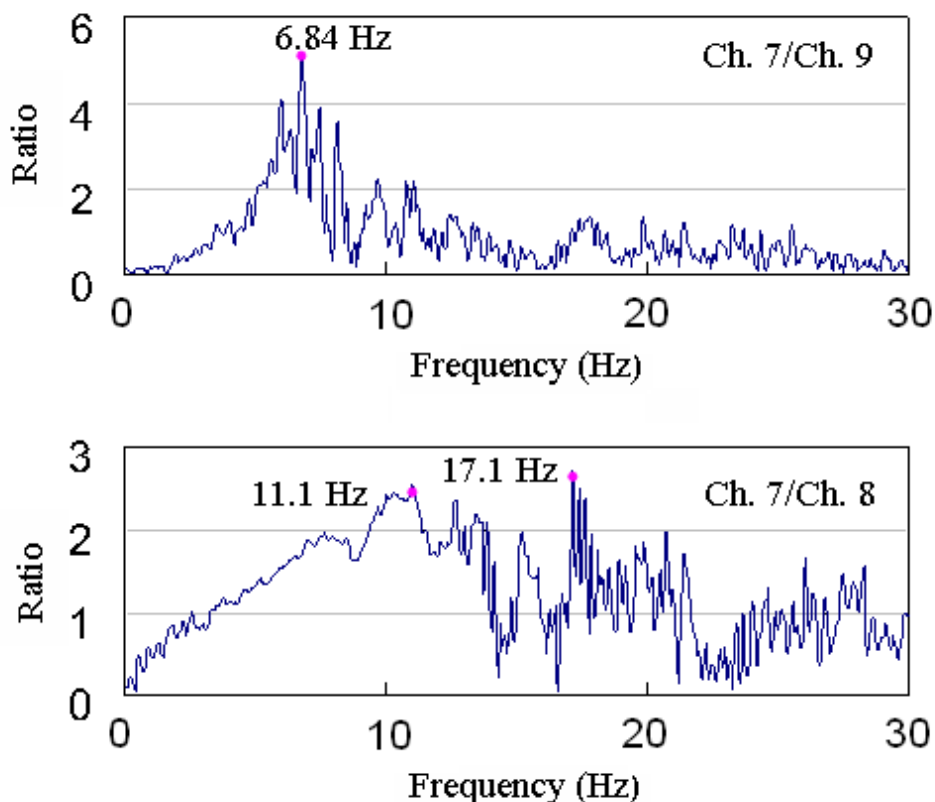
Figure 6. H/V spectral ratio along the EW direction in the Temple of the Three Windows

To estimate the dynamic characteristics of the Temple of the Three Windows, the transfer functions between Ch. 9 and Ch. 7 and between Ch. 8 and Ch. 7 were computed, which results along the EW direction are shown in Figure 6. According to these results, the predominant frequencies of the west wall is 6.84 Hz when considering the transfer function from the external ground surface to the top of the wall (Ch. 7/Ch. 9). When the transfer function from the inner ground surface to the top of the wall is considered, the predominant frequency is 17.1 Hz (Ch. 7/Ch. 8).

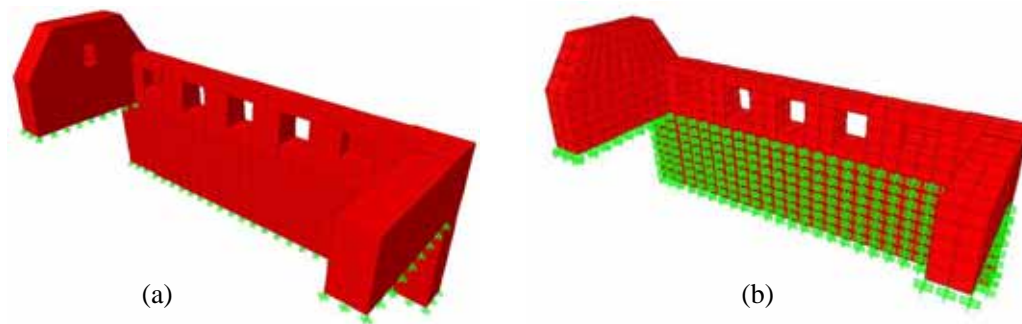
Figure 7. FEM models considered for the Temple of the Three Windows

Since the ground levels of the external side and the inner side of the Temple of the Three Windows are different, two models were considered in the FEM analysis. The first model assumes that the east wall does not have contact with the inner ground, as shown in Figure 7(a). The second model considers that the wall is restrained by the inner ground, as shown in Figure 7(b). The walls were modeled using solid elements, and the elastic linear analysis was applied to compare the results with those obtained by micro vibrations. The appropriate value of the modulus of elasticity was determined by inverse analysis of the values of predominant frequencies estimated from transfer functions of micro vibration measurements. The value of 1.3 kN/mm^2 was obtained for the equivalent elastic modulus, giving good agreements between proper frequencies from FEM and predominant frequencies from micro vibration measurements. Table 1 shows a comparison of the results.

Mode	Micro vibrations	FEM
1 st Mode (Model of Figure 7(a))	6.84	6.93
2 nd Mode (Model of Figure 7(b))	17.10	17.30
