## SEISMIC VULNERABILITY OF LIMA CATHEDRAL, PERU

### ABSTRACT :

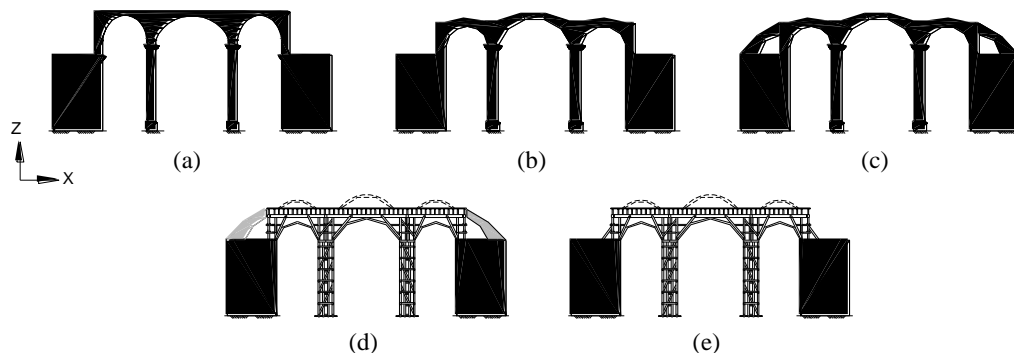
Figure 1a shows the original configuration, with masonry vaults which rested on oval arches. After the 1609 earthquake the Cathedral was reconstructed with full centered arches, Figure 1b. Figure 1c shows the flying buttresses which were added after the earthquake of 1687 to improve the lateral stiffness. After the great earthquake of 1746 the pillars and the roof structure were completely rebuilt in wood, Figure 1d. In 1898, a complete reconstruction of the roof structure (vaults, arches and horizontal frame) was carried out. For the first time in the history of the Cathedral, changes in the structure were not due to earthquakes but to the attack of

termites and humidity, which had caused great deterioration of the wood elements. Figure 1e depicts the current configuration of the structure. The flying buttresses were removed after 1940.

Figure 1. Cross sections of the building showing structural changes in Cathedral. a) Until the earthquake of 1609, b) Before the earthquake of 1687, c) Before the earthquake of 1746, d) After the 1746 earthquake, e) Present configuration

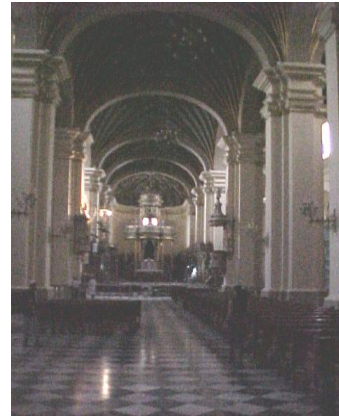
(b)

Fourteen 13m high wood framed pillars consist of eight columns, arranged in a cross shaped section, with horizontal and diagonal elements and an external cover made of wood, cane and plaster (figures 2b, 2d and 2e). These wood columns are not rigidly attached to the foundation; in some cases they penetrate up to 10cm into the foundation, but in others they only rest on top of it.

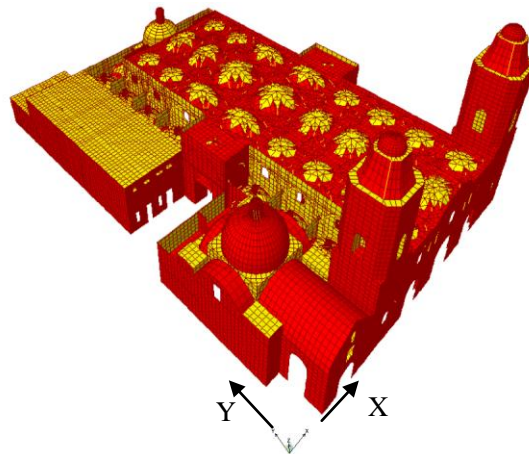
Figure 5 depicts the mathematical model for the analysis. 18,788 frame elements were used to represent wood elements from pillars, arches, vaults and the horizontal roof framework. The walls and the roof covers were modeled with 71,166 two dimensional shell elements.

Figure 5 Mathematical model of Lima's cathedral
