STRUCTURAL AND EARTHQUAKE RESPONSE ANALYSIS OF THE MURADIYE MOSQUE IN BULGARIA

ABSTRACT :

Recently, a large scale restoration has been started by the Great Municipality of Istanbul for the Muradiye Mosque of Filibe (Plovdiv), Bulgaria. Within this activity, the building is investigated in detail, damages of the building have been documented and soil testing has been carried out to identify properties of the soil and the foundation configuration. In this study, structural and earthquake responses of the Muradiye (Djumaya) Mosque of Filibe, Bulgaria, are investigated and by using these information a detailed repair and strengthening project is developed. The paper presents a summary of the results of the structural response analysis including seismicity of the building. Main principles of the recommended repair and strengthening interventions for the building are given as well. The authors participated to the project in developing geotechnical and civil engineering analysis and supplying technical support for its evaluation and strengthening.

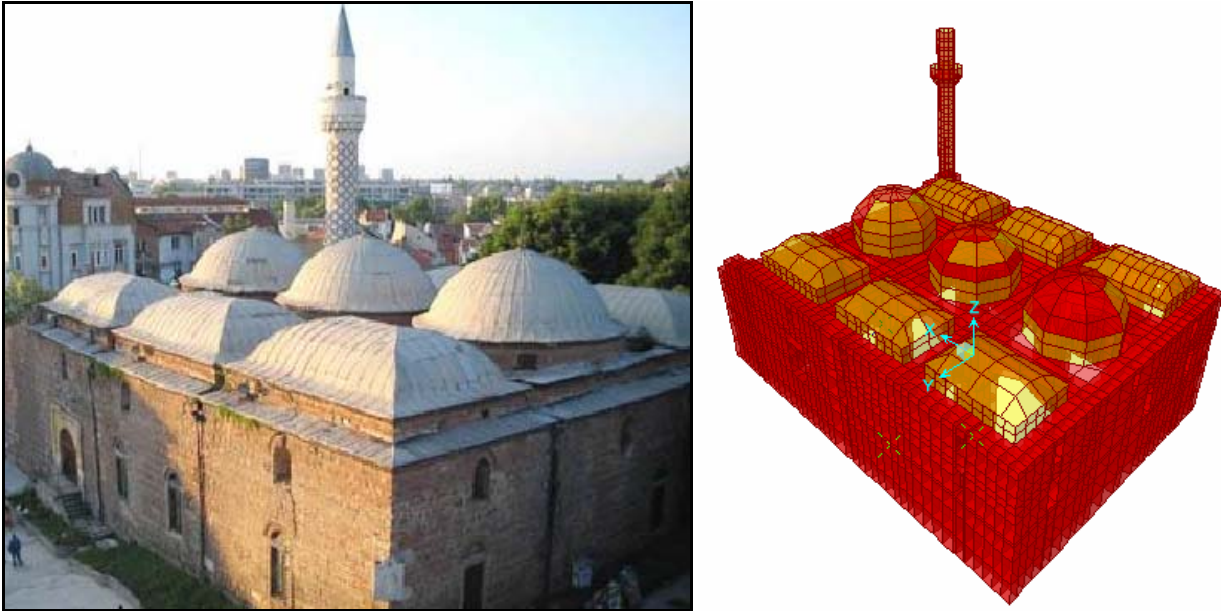
spherical domes and the two side ones – with three bed-shaped arches, supported by columns. The building material used is stone, brick and plaster. The domes and arches are covered with lead sheets. The structure consists of stones alternated with bricks. At the beginning of the 19th century, a wooden annex was constructed to the north and the ground floor of the annex was turned into a café (*Figure 1*).

Figure 1 Muradiye Mosque of Filibe and its structural finite element model
