## BEHAVIOR OF NON-ENGINEERED HOUSES DURING PISCO EARTHQUAKE 15/8/2007

C. Zavala<sup>1</sup>, M. Estrada<sup>1</sup>, L. Chang<sup>2</sup>, L. Cardenas<sup>2</sup>, J. Tayra<sup>2</sup>, L. Conislla<sup>2</sup> and G. Guibovich<sup>2</sup>

### ABSTRACT:

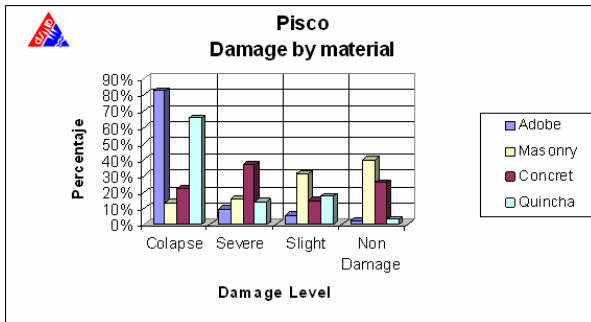
Figure 1 shows the results of field survey of Pisco City, by damage for each type of material used in the city.

From the total of adobe dwellings 82% collapsed, following by quincha buildings with 65% collapsed. Masonry buildings suffered less damage from the strike of the quake (slight damage and non damage) with 70% of them without high demand.

Figure 1: Damage by material in Pisco City

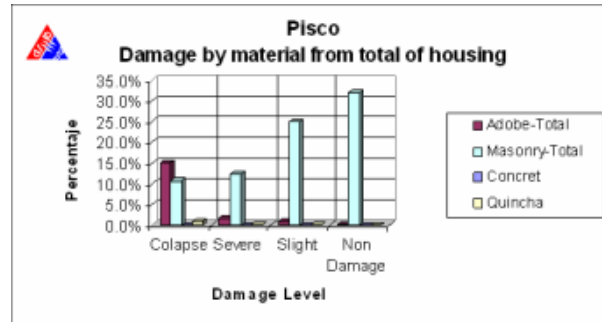
Figure 2: Damage related with total of buildings-Pisco

Figure 2 shows the percentage considering the total of the buildings of Pisco city. The adobe buildings that collapse in the city represents 15% of the total and the masonry buildings that collapse represents 10.7% of the total of housing.

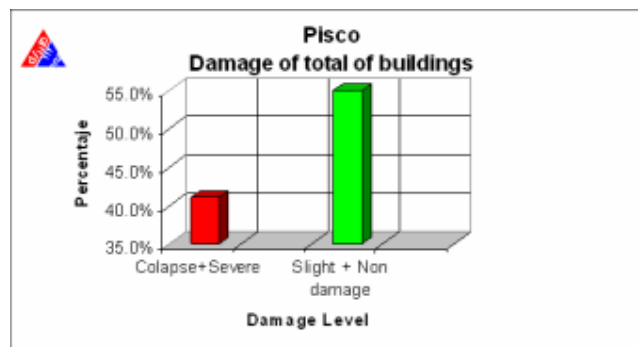
Figure 3 shows the summary of the collapsed and severe damaged in comparison with the slight damage buildings and non damaged buildings. It is possible to read that 41.1% of the housing was more affected originated collapse and 58.9% were less affected by the quake. From the severe affected buildings most of them were non engineering structures.

Figure 3: Damage of buildings in Pisco

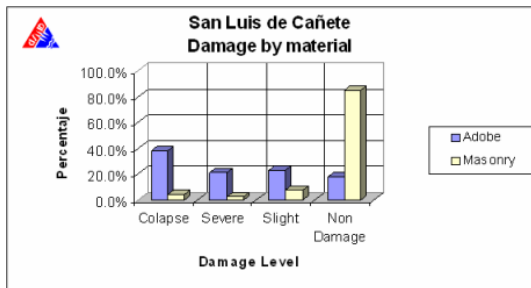
Figure 4 presents the survey on this city by material type where 37.8% of adobe houses collapsed and 85% of masonry houses didn't have damage. Figure 5 presents the results by material considering the total buildings, where 23% of affected houses were built by adobe which is the representative of the city with 62% of the total.

Figure 4: Damage by Material – San Luis

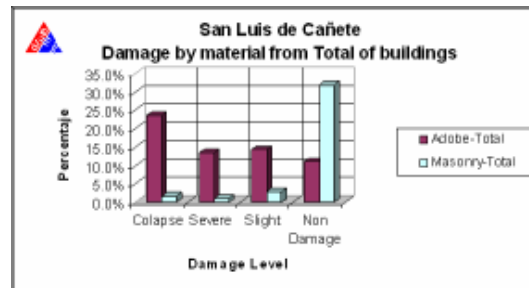
Figure 5: Damage by material from total

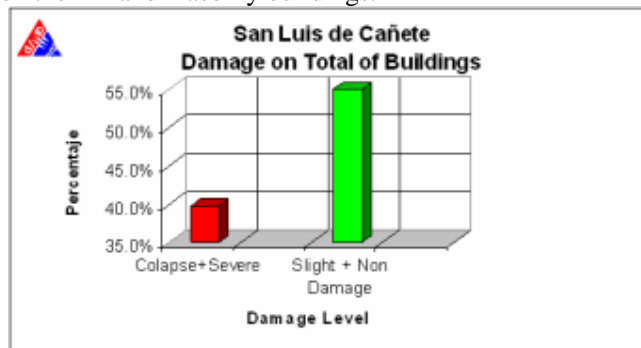
Figure 6 presents the addition of the collapse and severe damage in comparison with the addition of slight damage buildings and non damage buildings. We found that 39.8% of the buildings were more affected with collapse and severe damage mainly in adobe buildings. The 60.2% of buildings were less affected by the quake represented by the houses on the hill and masonry buildings.

Figure 6: Damage on San Luis Buildings

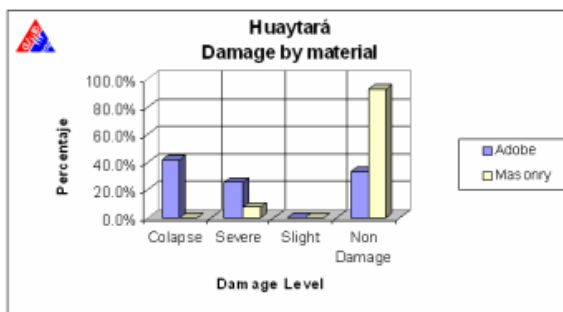
Figure 7, presents the distribution of damage by type of material in Huaytara city. The 41.1 % of adobe houses were affected with collapse, and 25.7 % de present heavy damage. The 92.6 % of masonry buildings didn't have damage. Figure 8 shows the damage considering the total of buildings in Huaytara city. Here the 34.8 % of the adobe houses had collapse and the 21.7 % present's heavy severe damage.

Figure 7: Damage by material – Huaytara

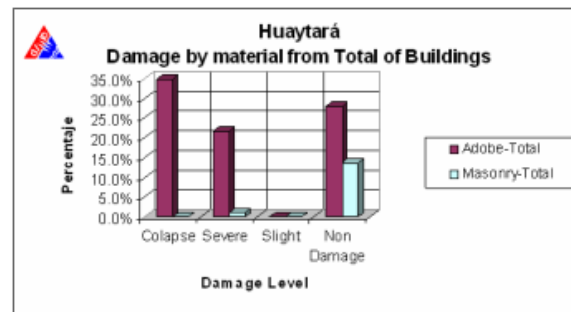
Figure 8: Damage by material from total

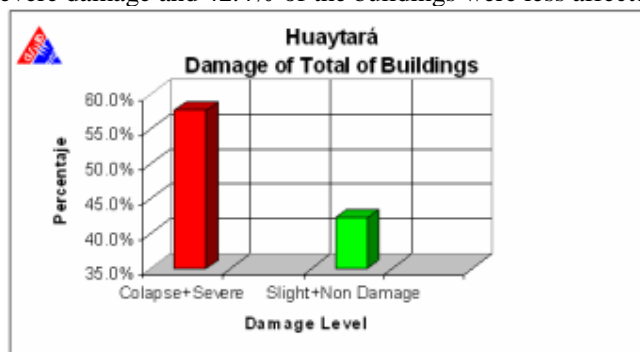
Considering the addition of the collapse and severe damage and comparing with the addition of slight damage and non damage, Figure 9 shows the results of this comparison. It was found that 57.6 % of the houses were affected with collapse or severe damage and 42.4% of the buildings were less affected.

Figure 9: Damage on Huaytara buildings

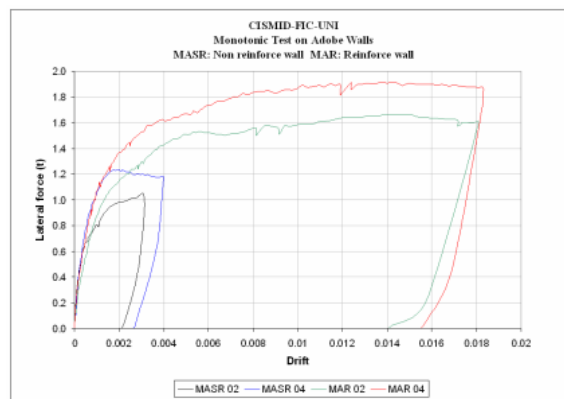
Two walls under monotonic loading were experimented in our laboratory. Two walls were of 2.45 m. length, 2.30 m. height and 0.20 m. thickness was tested without reinforcement. Under monotonic load an average of 1.153 t for a drift 1/250 was registered. The walls were repaired using the proposal and tested again under the same conditions. A maximum load of 1.790 t was reached for this alternative of reinforcement. The load capacity increase in 65% the drift can resist deformations for drift between 1/250 a 1/60 after the reinforcement.

Figure 10: Monotonic Test on adobe walls

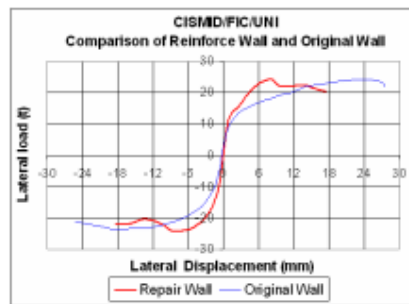
Figure 11 presents the comparison of the results of the behavior curve of specimens, where repair wall appears with thick line and original wall with thin line. The stiffness on the repair wall was restored but small ductility was observed. A separation of the mesh started under a drift of 1/333 and it continued until a drift of 1/166 when the toe collapsed.

Figure 11: Behavior curve from cyclic loading test
