RECONNAISSANCE REPORT ON STRUCTURAL AND GEOTECHNICAL ASPECTS OF DAMAGES IN A RECENT EARTHQUAKE IN JAPAN

This paper outlines the geotechnical and structural hazards brought by the 2007 Niigataken Chuetsu-oki earthquake that occurred in the Niigata and Nagano prefecture, Japan on July 16th, 2007 (JST). The quake brought heavy damages to many wooden residential houses and traditional wooden buildings. This paper is a report of preliminary joint investigation on the structural and geotechnical aspects of the damages. Ground vibration and ground deformation were found to be the main cause that led to damages to low earthquake resistant buildings and other associated damages during the earthquake.

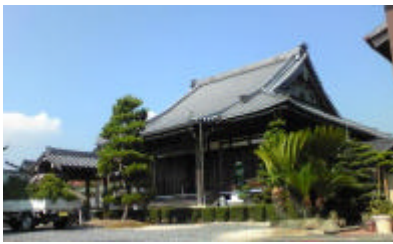
Figure 5. Monkoji temple
 (before the damage)

The worst affected amongst the traditional structures was the Monkoji Temple (Figure 5) recognized by the city government of Kashiwazaki as architectural heritage. The temple, located at Nishi-Honcho of Kashiwazaki City, was completed in 1930. In 1955 roof of the main temple was changed from copper plates to tiles. The 2004 Niigataken Chuetsu Earthquake ($M=6.8$) brought some moderate damages to the temple, and, therefore, the roof tiles of the temple were replaced 3 years ago (after the earthquake). The salient features of the temple are the western-style large-span roof frame and less no. of pillars used in the inner temple and prayer hall. The fired clay roof tiling contained no clay sheathing. The 2007 earthquake resulted in the complete collapse and destruction of the main temple (Figure 6).

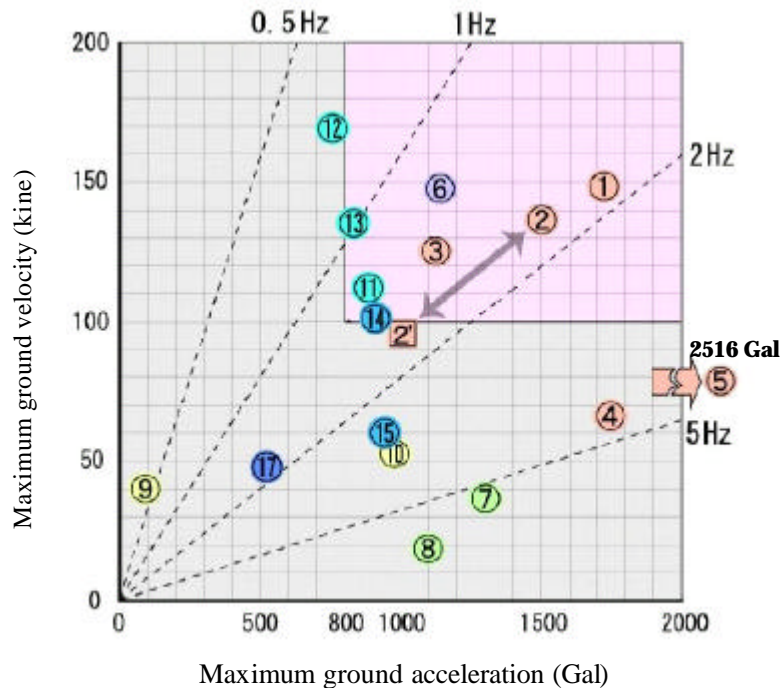
Figure 8. Criteria for estimating severe damages on structures based on PGA and PGV (After NEID , 2007)

Applying the values of PGA and PGV recorded at the K-NET recording station installed at Kashiwazaki (NIG018) in Eq. (3.1), a value of about 1.02 Hz is obtained for EPF (number shown in red in Figure 8). Location of number lies in the pink area, indicating the reasons for the rampant damages on buildings near this earthquake observation site. However, this value of EPF is not concordant with the predominant frequency (0.4 – 0.5 Hz) obtained in Figure 3. This implies a strong non-linear behavior of the ground.

Thus, a comparison between the values of predominant frequencies in acceleration response spectrum of strong ground motion and the values of equivalent predominant frequency (EPF) could yield a good clue to strong non-linear behavior of the ground. Analyses of the H/V spectra of many observed motions during the earthquake show that the predominant periods of the weakest motion and the strongest motion were not the same, and the stronger period's predominant period had developed into a long period component (JSCE, 2007). Each of the observation station contained sand layers with small N-values in the upper layer (Niigata Prefecture, 2002), and therefore, influence of a non-linear response during strong vibration cannot be ruled out.

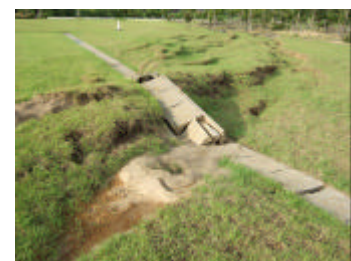
Figure 18. Uplifting due to lateral flow
