## AN OUTLINE OF DAMAGES TO SCHOOL BUILDINGS IN DUJIANGYAN BY THE WENCHUAN EARTHQUAKE ON MAY 12, 2008

Toshimi Kabeyasawa<sup>1</sup>, Toshikazu Kabeyasawa<sup>2</sup>, Koichi Kusunoki<sup>3</sup>, Kangning Li<sup>4</sup>

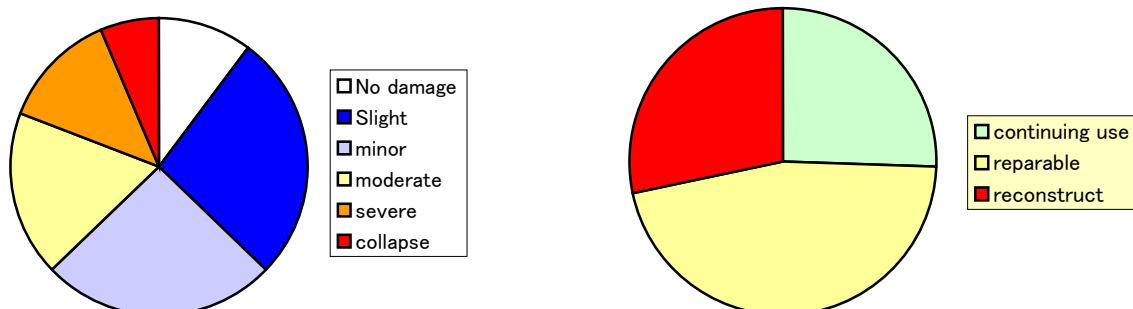
Figure 3 Overall damage rates and post-earthquake functionality

The overall statistics for the damage rates, the heavier rate of two directions, are shown in Figure 2. The ratios of the classified damage grades to the total number were (0)10%, (1)27%, (2)26%, (3)18%, (4)13%, and (5)6% for (0) No damage, (1) slight, (2) minor, (3) moderate, (4) severe, and (5) collapse or near collapse, respectively. About 20% of the school buildings were collapsed or severely damaged and 20% were moderate, while 60% were minor, slight or no damage. Photos of typical damage examples in each grade are shown in Figure 3.

The post-earthquake recovery is also recorded as shown in Figure 2, which are classified as (1) functional for continuous use, (2) repair/strengthening and reuse, and (3) demolish and reconstruction. As for the demolishment, a few of them had been executed, some of them decided and marked on the buildings by the administrators. The authors judged possible execution in the other cases. As for the repair/strengthening, the authors estimated the probable judgment in most cases. The relations between the damage grades and the post-earthquake recovery are also shown in Figure 4.

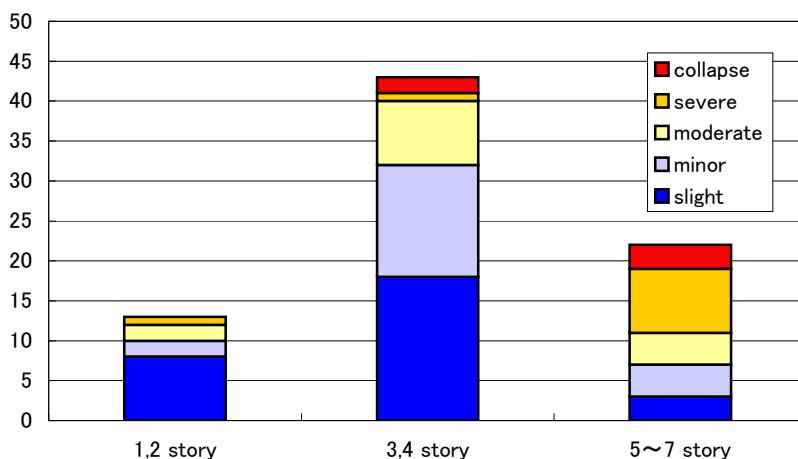
Figure 5 Damage rates and story number

The damage rates were analyzed with the number of story of the buildings as shown in Figure 5. Buildings in one or two story had relatively slight damage rates, only one high story-height piloti building was severely damaged out of 13 buildings. Only three buildings (one is for damage of base foundation, two are already taken away) were severe or collapse out of 43 buildings in three or four story buildings, while half, 11 of 22, were severe or collapse in five to seven story buildings. It may be concluded that the heavy damage rates are apparently higher for higher buildings.

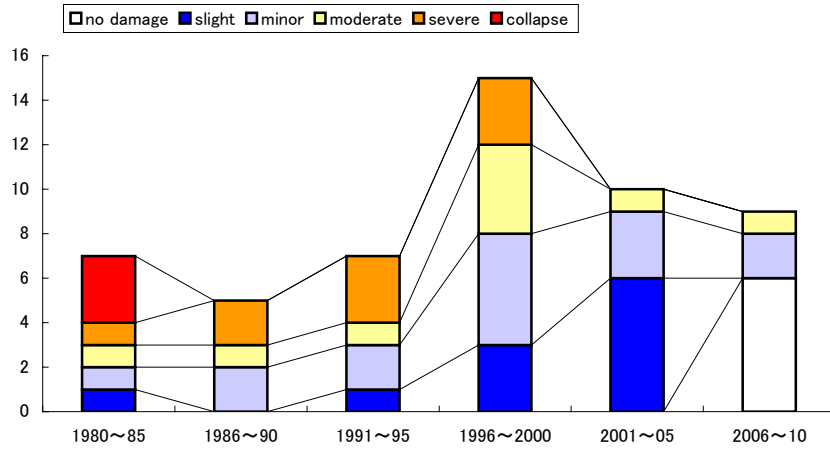
Figure 6 Damage rates and construction year

The transition of the damage rates with construction year of the buildings is shown in Figure 6. The rates were shown each for the half decade. More than half of the buildings constructed in 1980 to 85 were collapsed or severe, while the heavy damage rates decrease for buildings constructed in later years. There were no severe nor collapse for the buildings constructed after 2001, and two thirds of these were slight or no damage. It may be concluded that the damage rates of recently constructed buildings were apparently slight or minor, while serious damages such as collapse and severe were observed in older buildings.

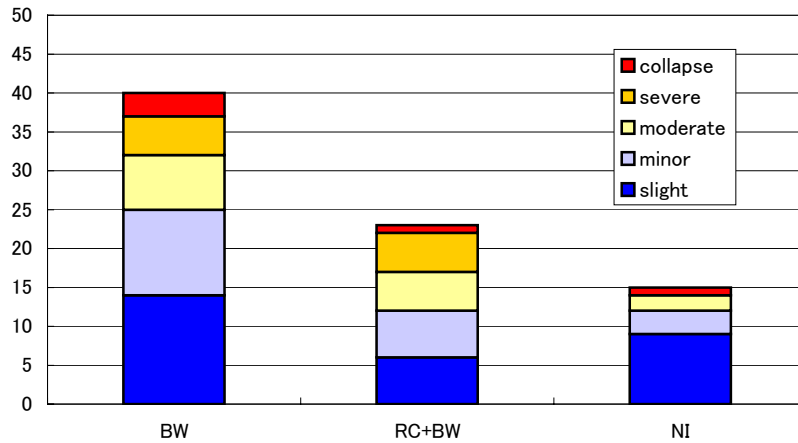
Figure 7 Damage rates and construction type

The damage rates were compared for the type of structural systems, the masonry structures or the reinforced concrete frame with brick or masonry infill walls. As shown in Figure 7, there were no obvious differences between the damage rates of the buildings in the two structural systems. It should be noted that the damage rates of the masonry structures are not higher than those of the reinforced concrete frames, probably owing to relatively thick masonry walls and relatively larger amount of sectional dimensions of the vertical members.

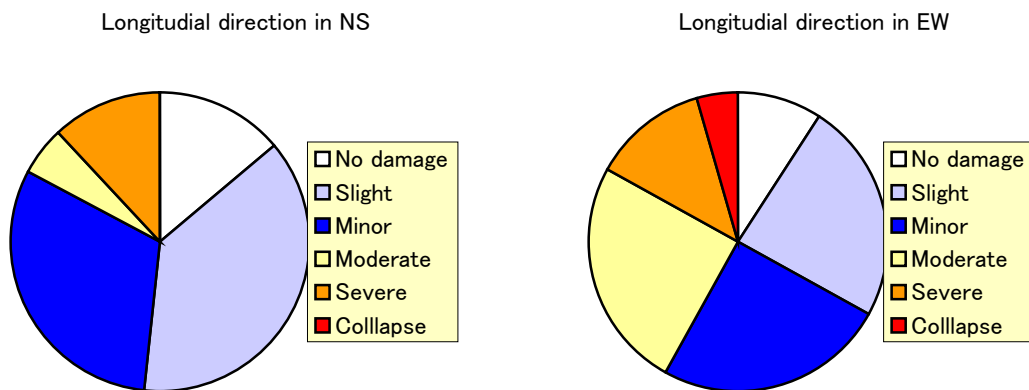
Figure 8 Damage rates and longitudinal direction of buildings

The longitudinal direction of the school buildings was located either in EW-direction or in NS direction. Therefore, the damage rates judged for the longitudinal direction were analyzed with the location of longitudinal directions of the buildings, as shown in Figure 8. Relatively heavier damages are observed in case the longitudinal direction was in EW direction, so that the intensity of the ground motion in EW direction might be higher due to the directivity of the motion, which is orthogonal to the direction of the source fault line.

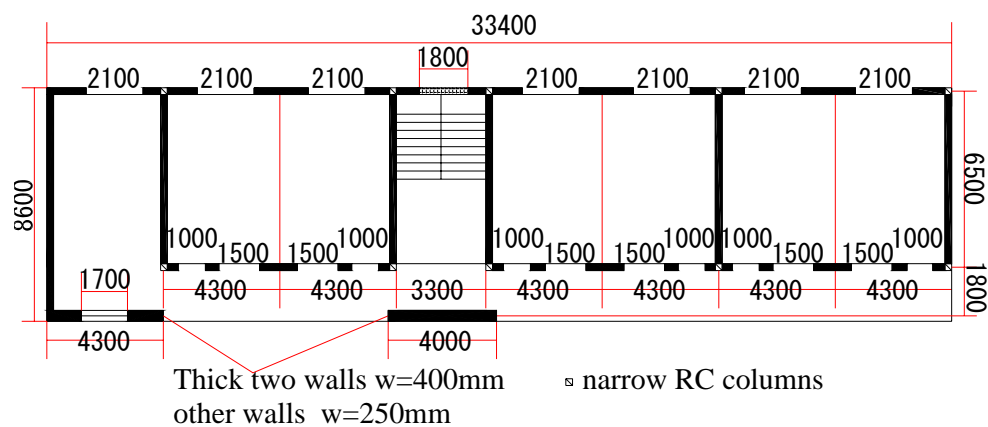
Figure 9 A typical floor plan of a three-story building in an elementary school

averaged stress of reinforced concrete columns is assumed as  $1.0\text{N/mm}^2$ . The weight of the structure was calculated from the floor area using  $12\text{kN/m}^2$  as averaged per unit floor area. Then the ultimate lateral load carrying capacities, which are expressed in terms of the base shear coefficient, are estimated as: (1) 0.55 in longitudinal direction and 0.67 in transverse direction for the first three-story building in Figure 9, and (2) 0.39 in longitudinal direction and 0.58 in transverse direction for the second four-story building in Figure 10.
