RECONNAISSANCE REPORT OF 0512 CHINA WENCHUAN EARTHQUAKE ON BRIDGES

Chu-Chieh Jay Lin¹, Hsiao-Hui Hung¹, Kuang-Yen Liu¹, Juin-Fu Chai²

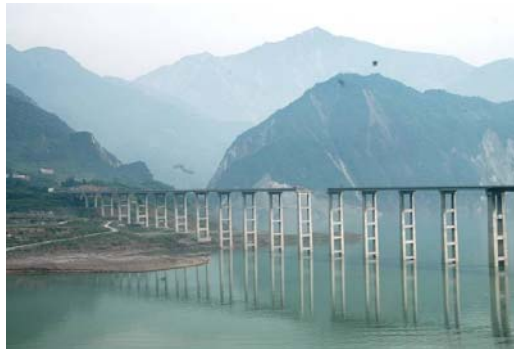
Miaotzuping Bridge is located at the water reservoir area (Zipingpu dam) near Dujiangyan. As shown in figures 15-18. This beautiful bridge is 1436 m long with 100 m height composed of main bridge (long span box girder bridge) and 19 approaches (T-girder bridge). The construction of the bridge is completed but not opened to traffic yet. There are spans shifting on both longitudinal and horizontal directions causing the damages of side stoppers. Besides, the earthquake caused one of the T-girder approaches collapsed due to possible insufficient support length of cap beam for falling prevention (narrow seat).

Fig.15 The approached of Miaotzuping Bridge

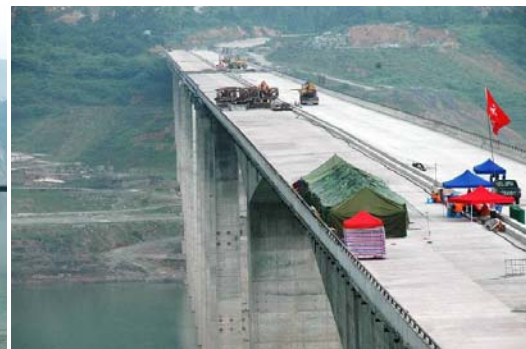
Fig.16 On top of Miaotzuping Bridge

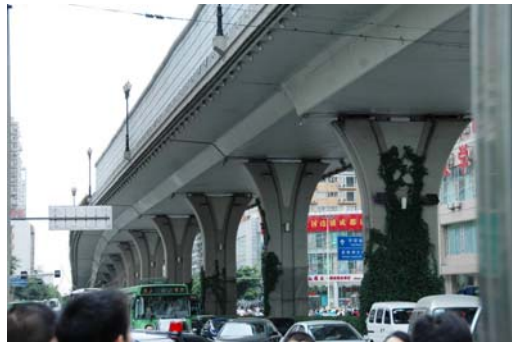
Most of the bridges at metropolitan cities remain intact, as shown in figures 29-30. However, the bridges at Mianzhu city suffered slight damages on expansion joints and remain in service with warning sign, as shown in figures 31-32.

Fig.29 Viaduct at Chengdu

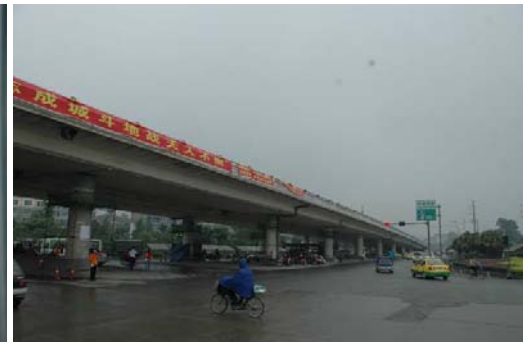
Fig.30 Bridge at Dujiangyan
