## OUTLINE INTRODUCTION OF BUILDING DAMAGE IN HIGH INTENSITY AREAS OF WENCHUAN M8.0 EARTHQUAKE

**Sun Jingjiang Meng Qingli Ma Qiang Shi Hongbin Sun Zhongxian**

*Institute of Engineering Mechanics, China Earthquake Administration, Harbin 150080, China  
Email:jingjiangsun@sina.com*

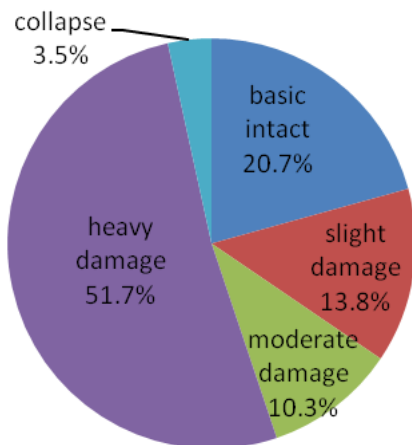
Fig. 39 Brick and BBF building damage ratios of Doujiangyan

Most of old houses (including brick-wooden houses and no drawing self-built buildings) and non-formal design buildings collapsed or heavy damaged; There are no significant difference in damage ratios between brick and FFB buildings; The damage ratios of brick and BBF buildings in Doujiangyan City and west region of Mianzhu City are shown in Fig.39 and Fig.40 respectively according to our sample survey data; The concrete buildings show better seismic performance than other types of buildings.
