## The performance of girder bridges in the Wenchuan Earthquake and a new method for seismic protection

Y. Huang

### ABSTRACT:

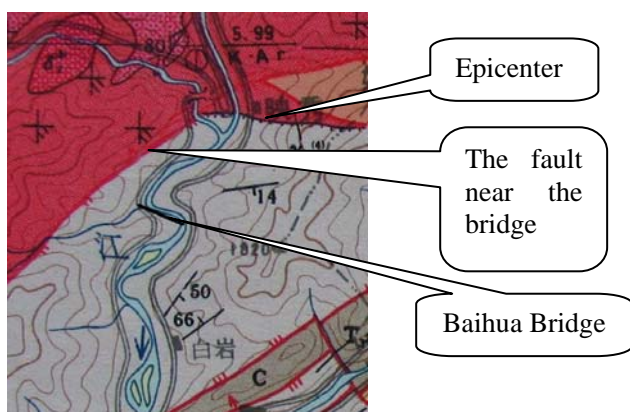
Fig.2 Geological structure near Baihua Bridge

Several factors influenced this bridge's performance during the earthquake. From Fig.2, we can find that there is a fault which is less than 1 km away from the bridge, and the bridge site is only 4.2 km from the epicenter. The short distance from the epicenter meant that very large accelerations were arriving at the bridge. This is also reflected in the ground motions record near the site. Form Table 2.1, we can find that the peak acceleration on the ground of Wenchuan Wolong Station, which is on the west side of the bridge and is the nearest station from the site, is up to 0.96g on EW. The large displacement of the ground near Abutment A1 resulted abutment and piers moving and deflecting. Meanwhile, the inertia force of superstructure pushed the piers which support the

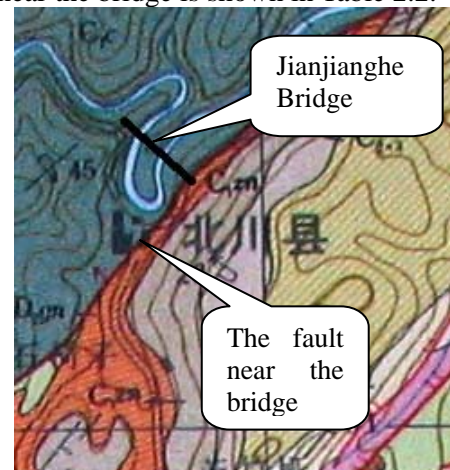
Fig.7 Geological structure near Jianjianghe Bridge

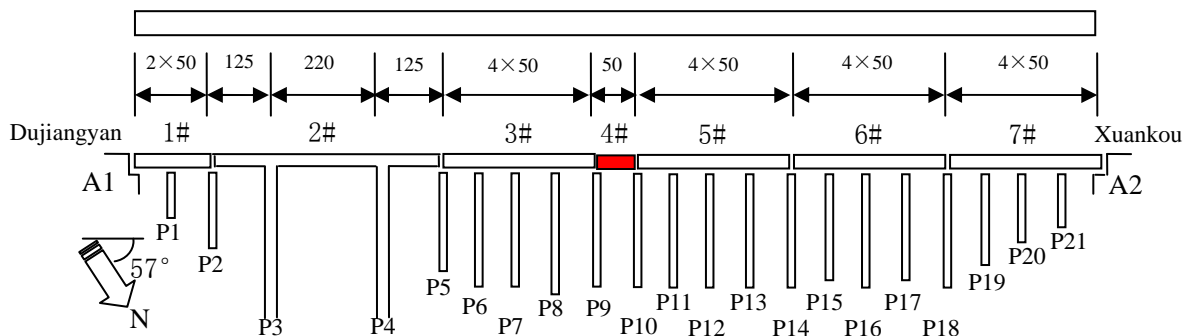
Fig.10 The plan drawing and elevation drawing of Miaoziping Bridge

During this earthquake, the severest damage of this bridge is 4# girder falling down. The other damages including the movement of 3# and 5# girder, the deflection of guardrail on Pier P5, and the ruin of block on P9 and P10. Excessive earthquake action makes the excessive relative displacement between flexible pier and girder more than 1 meter that the bridge had originally been designed according to intensity VII (JTJ 004-89, 1990), which result in a span girder falling down.

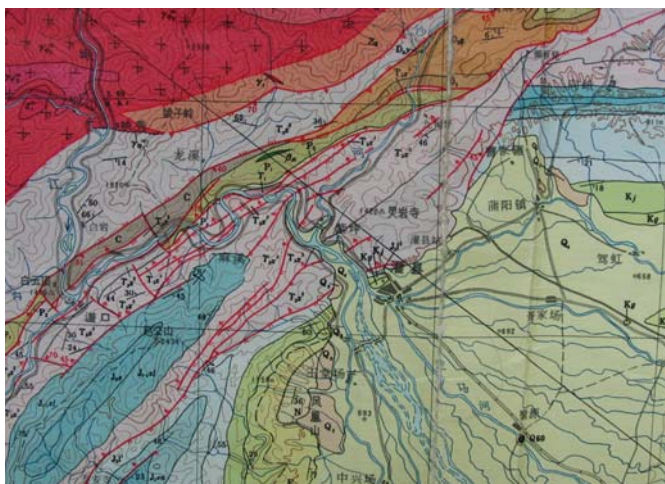
Fig.11 Geological structure near Zipingpu Reservoir

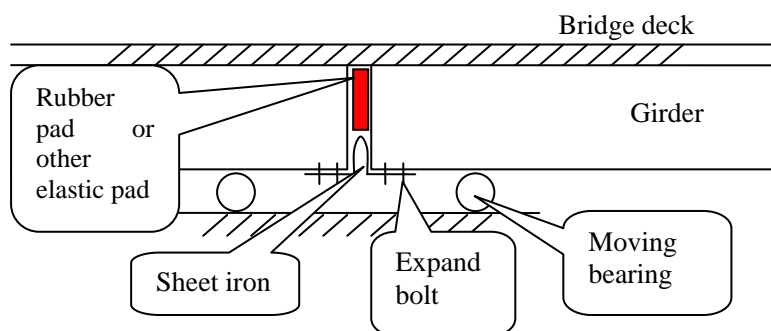
Fig.15 New constructional measure on girder bridge

Firstly, change all the bearing to the rolling one. Consequently, the superstructure can keep basically isolating from the earthquake influence. Secondly, set the rubber pad or other elastic pad between the girders or between the girder and the breast wall of abutment. In this way, not only the possible impact action can be buffered, but the displacement of girder can be limited (Fig.15).
