SEISMIC SAFETY OF DAMAGED WELDED STEEL MOMENT FRAMES

A. ASTANEH-ASL, D. MODJTAHEDI, K. M. McMULLIN and E. D'AMORE

ABSTRACT

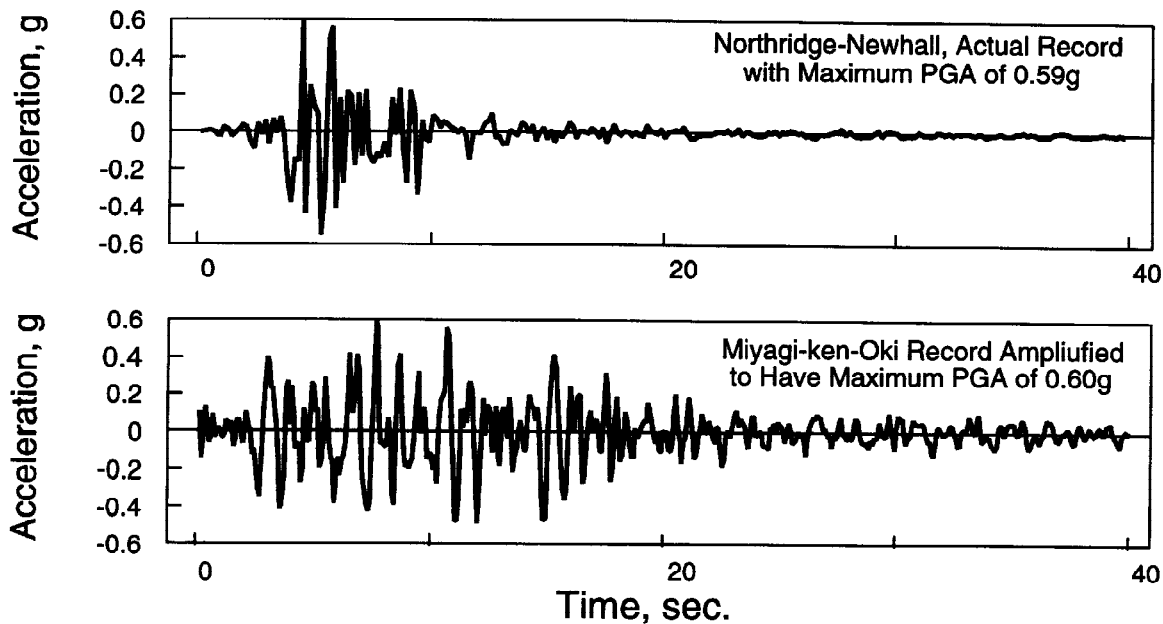
Fig. 6. Time history of the horizontal components of Northridge-Newhall record used in the study.

The inelastic models of the frames from three damaged buildings, shown in Fig. 1, were subjected to acceleration time histories of a variety of ground motions recorded in the past including records from the 1994 Northridge and the 1978 Miyagi-ken-Oki earthquakes. The record from the Northridge earthquake represents a high velocity, short duration, near field earthquake while the amplified Miyagi-ken-Oki record represents a relatively long duration earthquake with high energy distribution over a wide range of frequencies. Figure 6 shows acceleration time history of one of the horizontal components of the 1994 Northridge Newhall record and the amplified Miyagi-ken-Oki record used in this study. The Actual record of Northridge-Newhall had a maximum peak acceleration of 0.59g. The Miyagi-ken-Oki record was amplified to have a maximum peak acceleration of 0.6g. In all time-history analyses, the kinematic nonlinearities in the form of P- Δ effects were included.

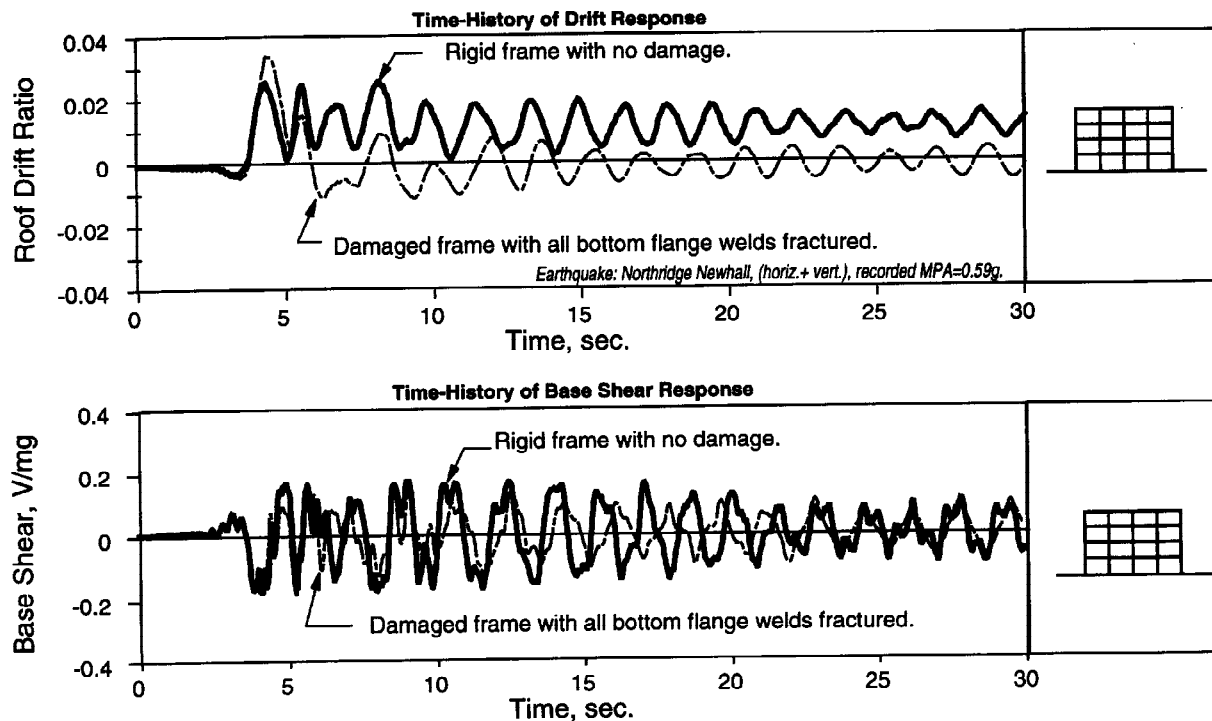
Fig. 7. Response of 4-story undamaged and damaged frames.

Figure 7 shows base shear and roof drift time histories of the 4-story frame to the Northridge-Newhall records. The drift time history plot indicates that during the first cycle roof drift of the damaged frame is greater than the undamaged frame. However, beyond the first cycle, the damaged structure shows much less drift than the undamaged structure. In addition, the damaged structure oscillates about the vertical axis without developing any major permanent out-of-plumbness. However, the undamaged frame, oscillates about a permanent drift of about one percent. Figure 6 indicates that throughout the motion, the base shear developed in the 4-story damaged frame is less than the base shear in the undamaged frame.

It appears that when a rigid undamaged moment frame sustains damage it is converted to a semi-rigid frame. As a result, the damaged semi-rigid frame has smaller response. This phenomenon of smaller seismic response of semi-rigid frames relative to similar but rigid frames has been observed in other analytical studies as well as laboratory tests (Astaneh-Asl, 1994).

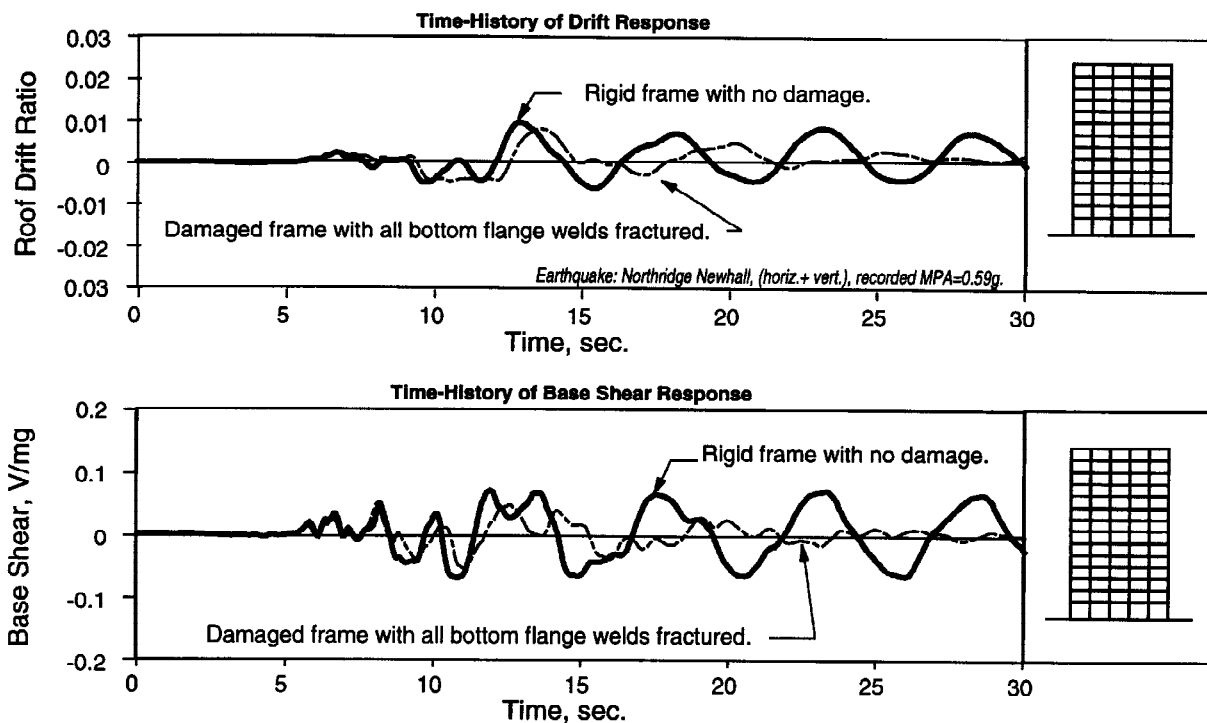
Fig. 8. Response of 14-story undamaged and damaged frames.

Figure 8 shows roof drift and base shear time history of the 14-story case-study frame. The ground motion used is the same Northridge-Newhall ground motion which was used for the 4-story frame discussed earlier. For this 14-story frame, the roof drift response of the damaged frame is less than the drift response of the undamaged frame throughout the time history. Particularly, the response of the damaged structure after first 22 seconds is very small while the response of undamaged structure is still considerable, Fig. 8. Once again,

it appears that the semi-rigidity of the damaged frame is the main reason in reducing the response of the damaged frame relative to the response of the undamaged frame.

Similar to the 4-story frame discussed above, the base shear of the damaged 14-Story frame was also much smaller than the base shear of the undamaged frame. This phenomenon was consistently observed when various levels of intensity of a number of different past earthquake records were used. Another observation of the results of analyses was that for undamaged frames the first mode appeared to be very dominant while for the damaged and semi-rigid frames, higher modes were also equally present. This can be observed in base shear time history shown in Fig. 8 where the full line curve which is for undamaged frame shows dominance of first mode while the dashed curve for damaged frame shows higher modes with shorter periods.

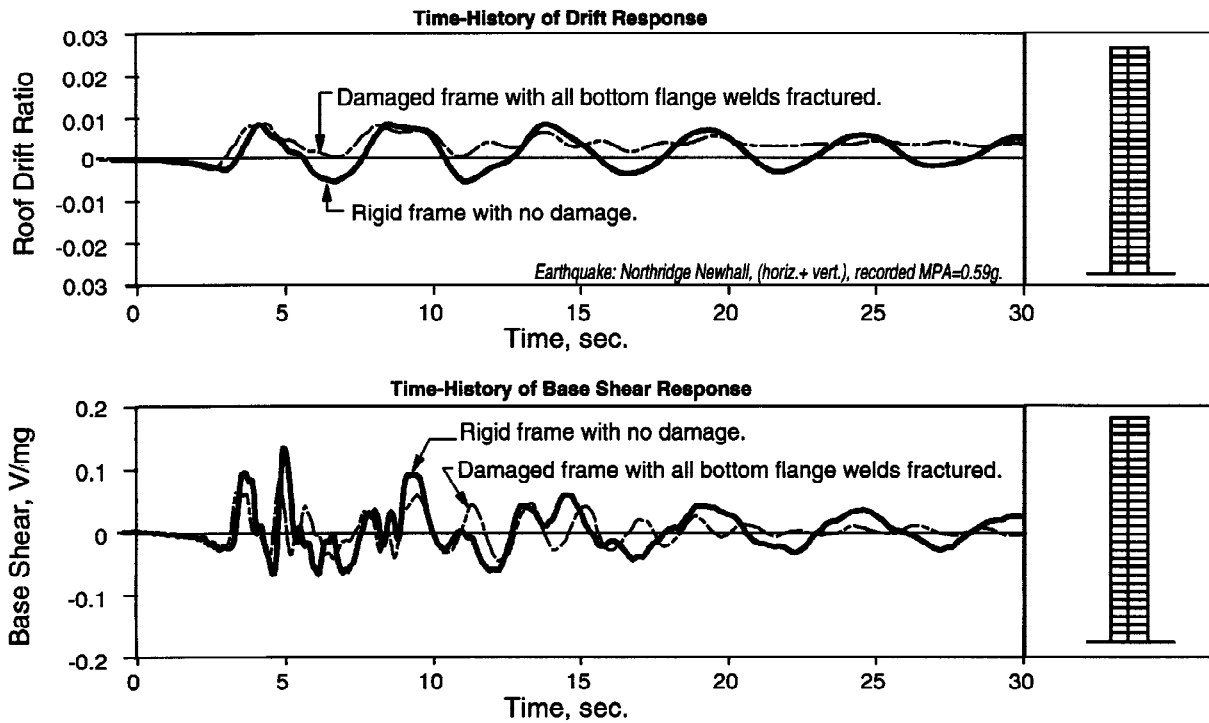
Fig. 9. Response of 27-story undamaged and damaged frames to Northridge-Newhall records.

Figure 9 shows roof drift and base shear time history of the 27-story case-study frame. The ground motion used is the Northridge-Newhall ground motion with 0.59 PGA. Similar to the 14-story frame discussed earlier, the roof drift response of the damaged 27-story frame is less than the drift response of the undamaged frame throughout the time history.

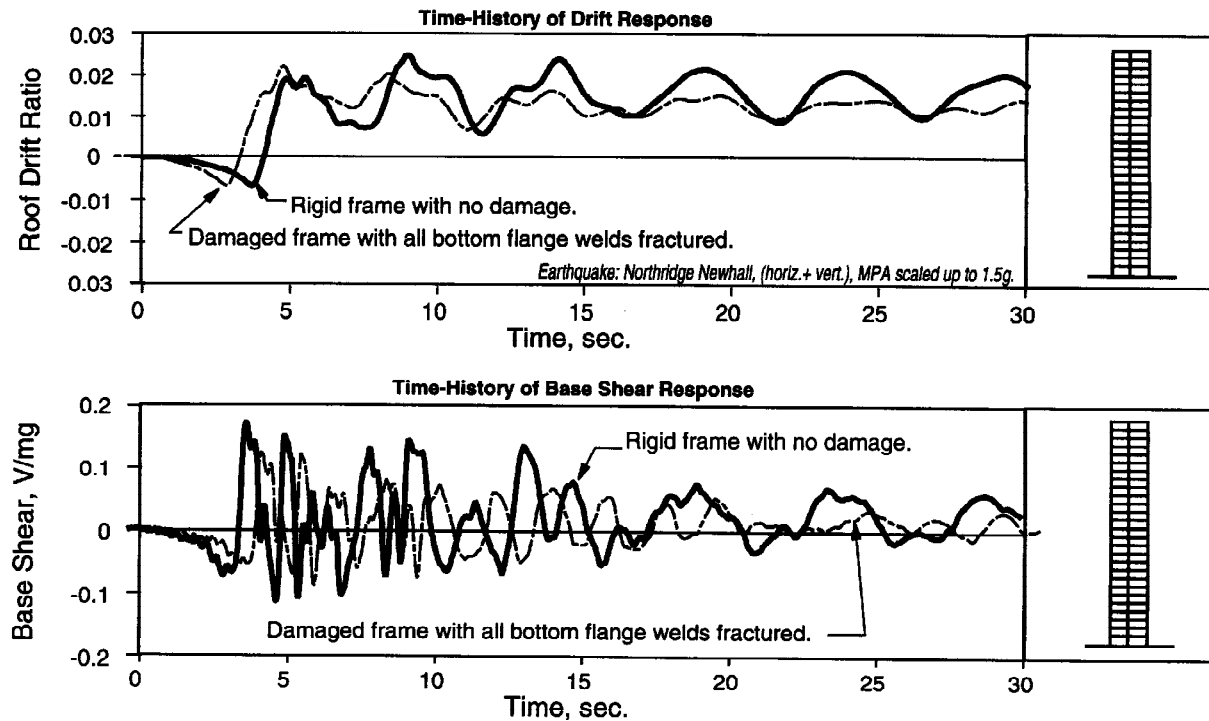
Fig. 10. Response of 27-story undamaged and damaged frames to Northridge Newhall records amplified to have 1.5g maximum PGA.

To study the possibility of collapse of damaged steel frames, the case-study frames were subjected to ground accelerations with ever-increasing maximum peak accelerations. Figure 10 is a sample of results obtained from these analyses for the 27-story case-study frame. In this case, the frame was subjected to horizontal and

vertical components of the Northridge-Newhall records with maximum peak accelerations amplified to 1.5g. As mentioned earlier, maximum PGA for Northridge-Newhall record horizontal and vertical components was 0.59g. As Fig. 10 indicates, the 27-story frame does not show a tendency to collapse. With the exception of first peak, the drift response of damaged frame is less than the drift of the damaged frame. The base shear response of the damaged frame is also less than the undamaged frame.
