REPAIR OF HIGH-STRENGTH REINFORCED CONCRETE BEAM-COLUMN JOINTS

K. TABATA and T. NAKACHI

In order to investigate the earthquake resisting ability of high-strength reinforced concrete members after repair, loading tests of interior beam-column joints were carried out. The variables were the concrete compressive strength and number of main bars of the beam. After repair of damaged specimens using low viscous epoxy resin and non-shrinking high-strength mortar, the second series of loading tests were carried out. The performance of repaired specimens whose joint shear deformation were not large during the original loading, was as good as that of the original specimens.

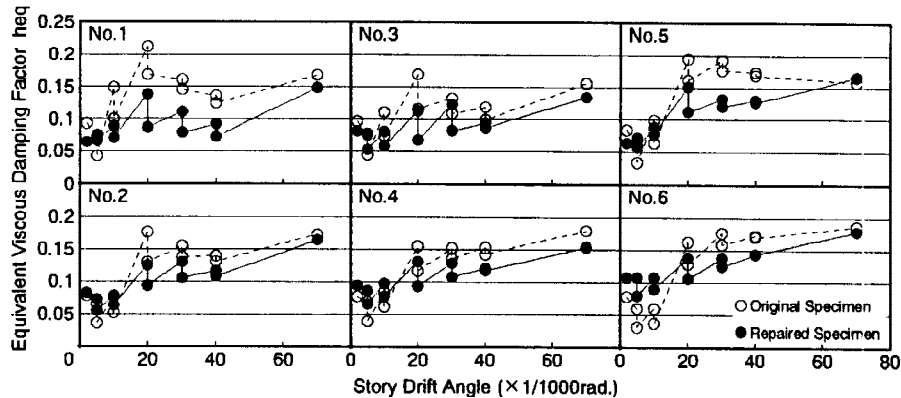
Fig.8. Equivalent Viscous Damping Factor

The relation between equivalent viscous damping factor heq and story drift angle is shown in Fig 8. In AIJ Design Guidelines (1990), heq is defined as being above 0.1 at $R=20/1000$, and the upper limit of bond index is recommended, so that bond splitting failure of the joint should not occur. The bond indices of all specimens approximate the limit. However, heq of all the original specimens remained over 0.1 not only at the first but also the second cycle of $R=20/1000$. In the specimens with the same number of beam main bars, heq increased, as F_c increased. From $R=20/1000$, heq of the repaired specimens was smaller than heq of the originals. The difference of heq of the BBo-type specimens before and after repair was larger than those of the other types. At the second cycle of $R=20/1000$, though heq of repaired specimens 5R and 6R were over 0.1, the heq of the other specimens were a little less than 0.1.

- (4) The equivalent viscous damping factor of the repaired specimens was about 0.1 at a drift angle of 20/1000 rad.
