## PILE FOUNDATIONS SUBJECTED TO LARGE GROUND DEFORMATIONS: LESSONS FROM KOBE AND RESEARCH NEEDS

Takashi TAZOH\* and George GAZETAS\*\*

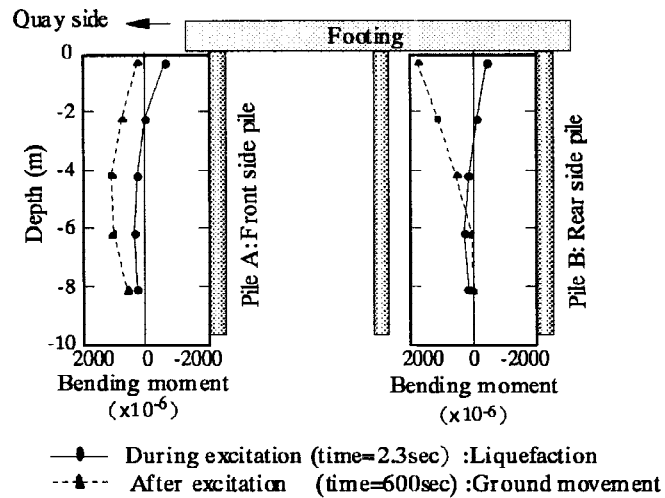
Fig. 4. Maximum bending moment along piles (Sato, *et al.*, 1996)

Tazoh *et al.* (1987) and Shimizu *et al.* (1992) carried out seismic observations on a road bridge and a 12-story building, respectively, constructed on soft soil deposit. These observations were made with accelerometers, strain meters, and pore water pressure meters on the superstructure, its foundation piles, and the ground. The observations aimed at investigating the actual response of piles and the predominant factors causing stresses and deformations in piles. As a result of the observations, the following conclusions were drawn. The axial strains on the piles decrease with the depth of the piles, but the bending strains are large not only at the pileheads, but also at the boundaries of soil layers where the stiffness varies significantly. The bending strains of the pileheads are primarily affected by superstructure inertia, while those at the pile-tips are significantly affected by ground shaking (Gazetas *et al.*, 1993).

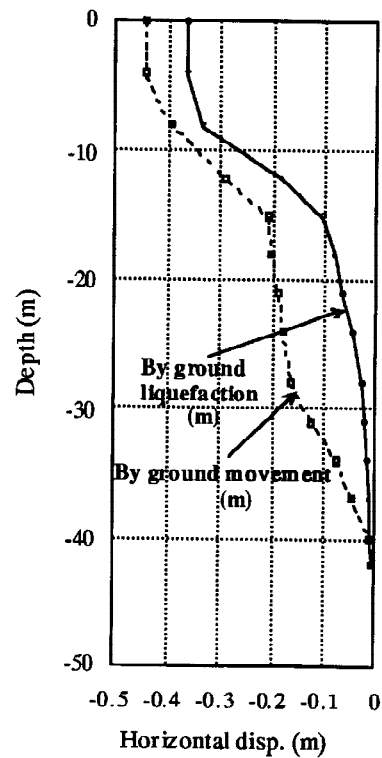
Fig. 6. Maximum horizontal displacement of pile (Fuchimoto, *et al.*, 1996)

Figure 6 plots the computed horizontal deformations versus depth. It can be seen that failure may occur at the pilehead, the middle part of the pile, and the pile-tip. The failures are apparently caused by large ground deformation due to liquefaction. The pile failure modes obtained from the analysis are compatible with those based on the damage investigation by Shamoto *et al.* (1995).
