GIS APPLICATION TO DAMAGE DATA MANAGEMENT ON BUILDINGS AND URBAN FACILITIES IN THE JANUARY 17, 1995 HYOGOKEN-NAMBU EARTHQUAKE

SATOSHI IWAI, HIROYUKI KAMEDA, YOSHIYUKI SUZUKI and SHIGERU KAKUMOTO

Disaster Prevention Research Institute, Kyoto University,
Gokasho, Uji, Kyoto 611, Japan.

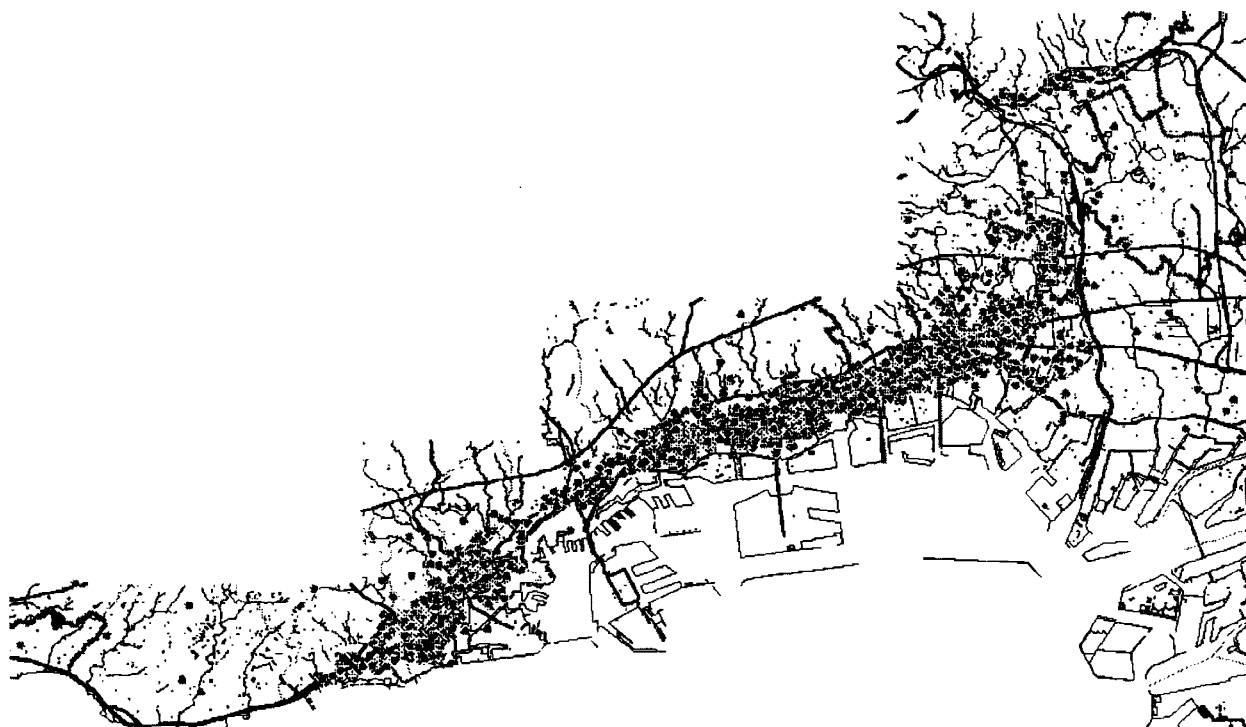
Fig. 2 Locations of deaths during the earthquake (data compiled by the Mainichi Newspapers).

Fig. 2 shows the locations where deaths took place during the earthquake. The data were compiled by the Mainichi Newspapers, and input activities were provided by the DPRI, Kyoto University and by Nara University. The casualties posed a tremendous problem in the Hyogoken-nambu earthquake. Correlation studies of these data with other types of damage should provide important information for future disaster mitigation and preparedness studies.

management phase. Although the data at this stage may still provide only crude estimates of the damage done, the areas in Fig. 3 in which the data are located agree remarkably well with those in Fig. 2, explained hereafter. This means that the data in Fig. 3 can greatly contribute to increasing the efficiency of the early stage operations of the disaster management activities of various organizations, which must all function under the extreme pressure of competition with time, and for which a quick overall identification of the damage situation is more important than precise data. On the basis of these observations, it is strongly proposed that the type of activities engaged in by the GSI and the dissemination of information be implemented in a standard disaster management protocol, hopefully in a way that their output be provided in much shorter period, say one day after the event.

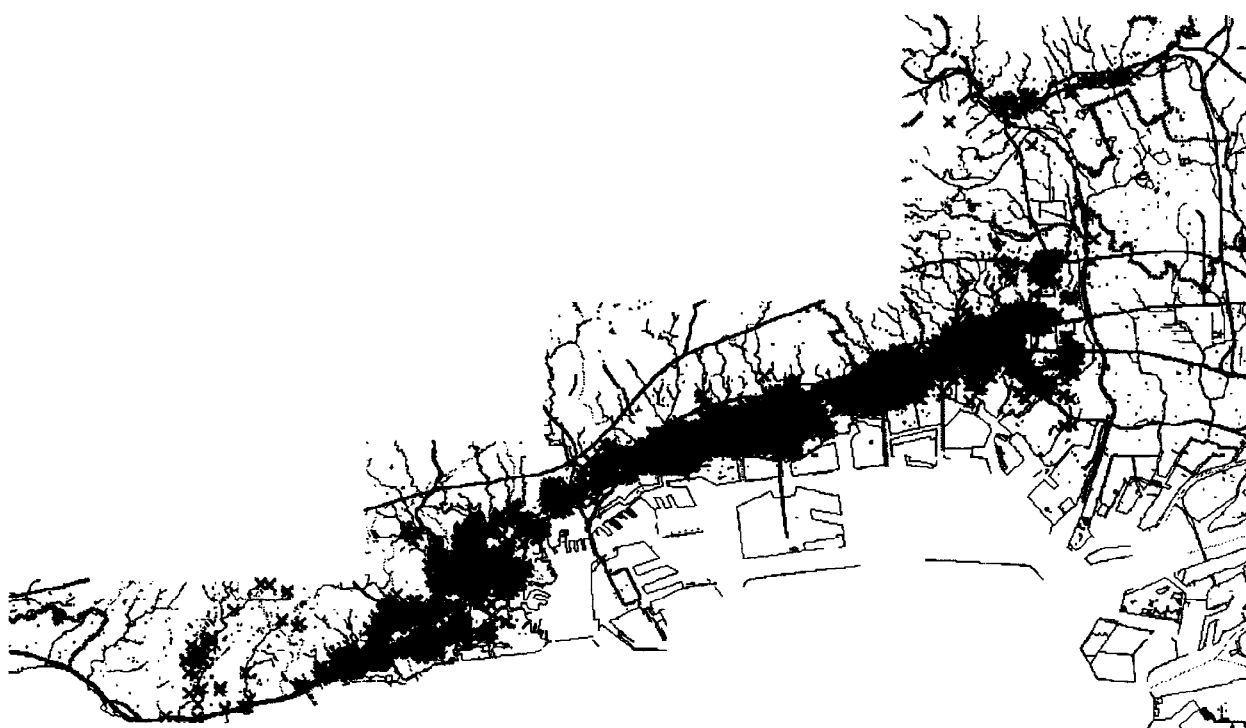
Fig. 3 Distribution of collapsed buildings based on aerial photographs taken by the Geographical Survey Institute (GSI) on January 17 and 20, 1995.

Fig. 3 shows a rough estimate of the structural damage done and its regional distribution based on aerial photographs taken by the Geographical Survey Institute, on the day of the earthquake and three days after the event. The photos were immediately processed in order to make quick damage estimation, and the data shown in the figure were completed as electronic information one week after the earthquake. It should be noted that the type of information given in Fig. 3 is very important in the immediate post-earthquake crisis

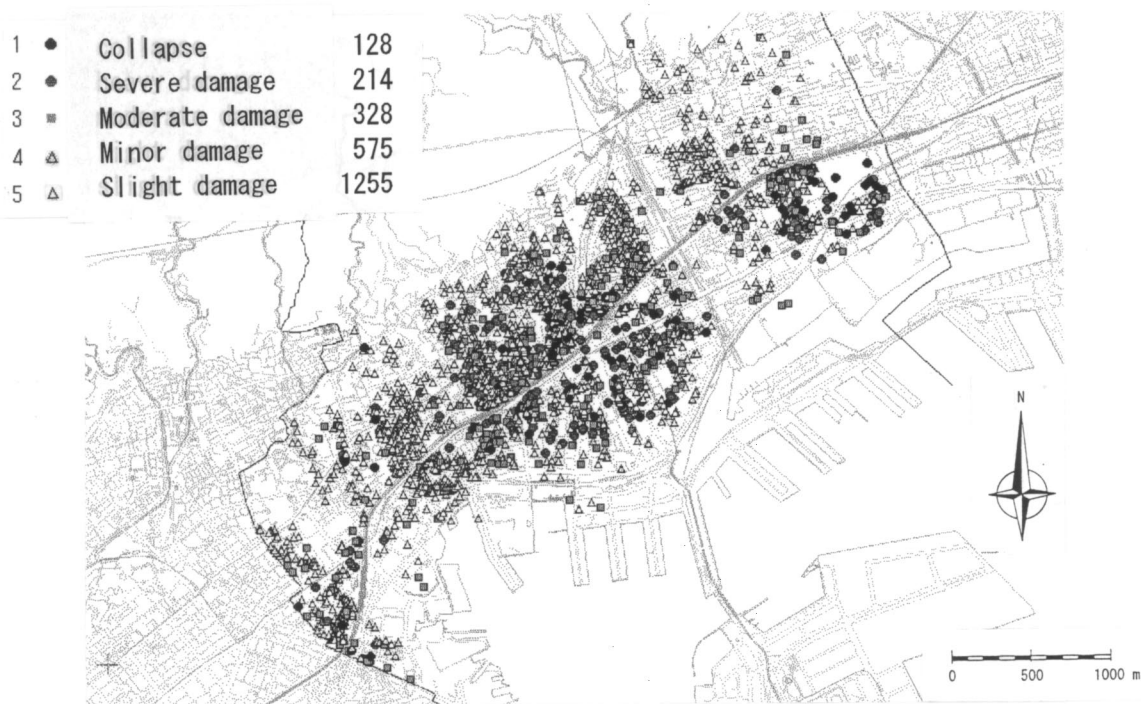
Fig. 4 Distribution of damaged buildings in Chuo Ward, Kobe City.

Detailed damage data are being compiled by various academic societies. The distribution of damaged buildings and their damage status in Chuo Ward, Kobe are shown in Fig. 4. This information has been compiled by reconnaissance teams from the Architectural Institute of Japan (Suzuki *et al.*, 1995, Nakashima *et al.*, 1995). Chuo Ward was mainly investigated by a team from the DPRI, Kyoto University. The findings should provide a solid basis for learning lessons from such a disaster which should be related to the enhancement of urban seismic safety through future activities. Moreover, the findings should provide very useful, accurate documents from which the details of post-disaster management can be planned. Apparently, this information is not being used effectively for these purposes. One reason may be that the findings collected basically are related to academic motivations, and another is that local governments are not equipped with evaluation and data processing systems. From this observations, it should be pointed out that much should be discussed on efficient use of information in the crisis management during an earthquake emergency to improve our response to such a disaster.
