## A SIMPLE EVALUATION METHOD FOR EARTHQUAKE DAMAGE TO THE QUAY WALLS

M. Soejima<sup>1</sup> and J. Ejiri<sup>1</sup>

<sup>1</sup> Dr. Eng., Structural Engineering Department, Technical Research Institute of OBAYASHI Co., Japan  
Email: soejima.michiyo@obayashi.co.jp, ejiri.joji@obayashi.co.jp

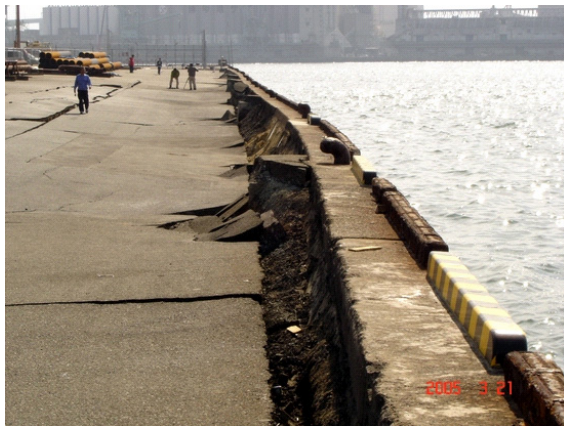
Figure 1 Large seaward displacement of quay

A lot of the quay walls which locate alongshore on reclaimed land having the important port and industry facilities have not sufficient seismic performance, because they were constructed in the old age. During 1995 Hyogo-ken Nanbu earthquake, many gravity quay walls suffered heavy damage as shown in Figure 1 and Figure 2.

Representative damage to gravity quay walls involves large seaward displacement and settlement with the value of several meters accompanying large settlement of backyard grounds caused by liquefaction of backfill sand. It is known that the shaking even with the JMA seismic intensity scale V did damage to the quay walls in the past earthquake.

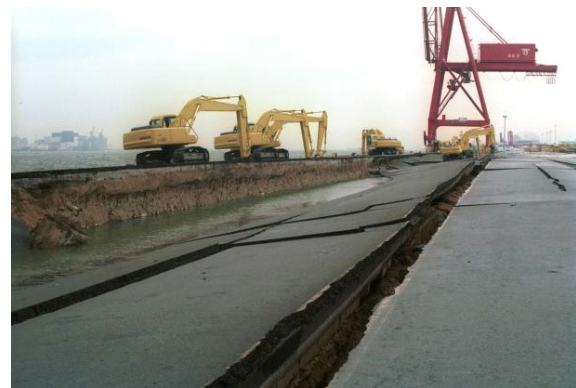
Figure 2 Large settlement of backyard ground

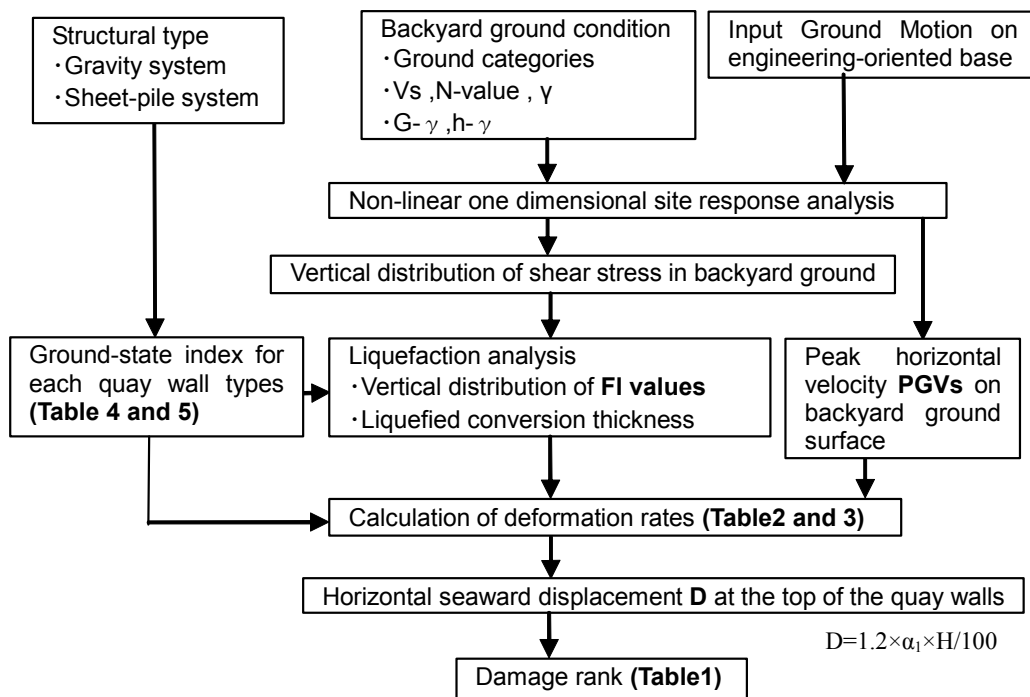
Figure 3 Flow of evaluation for earthquake damage to the quay walls

Figure 3 shows the flow of evaluation of earthquake damage to the quay walls by this method considering the damage level as horizontal seaward displacement  $D$  at the top of the quay walls as shown in Figure 4. Major parameters used for evaluation are quay walls structural types, peak horizontal ground velocity PGVs on backyard ground surface, thickness of liquefied backfill sand in backyard ground, liquefaction potentiality of the substitution sand mat beneath the quay walls. Two structural types are considered, one is gravity type and another is steel sheet pile type.

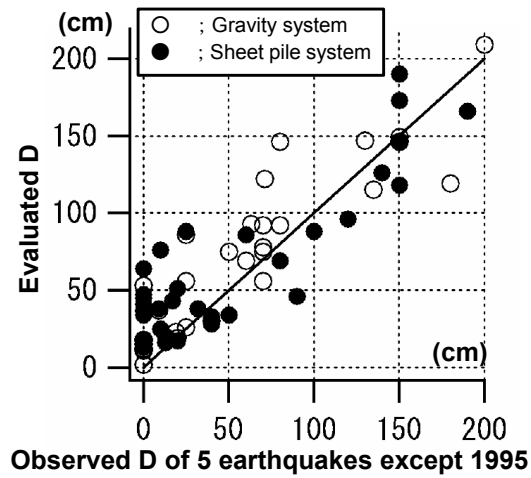
Figure 4 Comparison between Observed and Evaluated D

Figure 4 shows comparison of D values between Observed values of previous 5 earthquakes except 1995 Hyogo-ken Nanbu earthquake and Evaluated values by proposed evaluation method. D values were caused by the maximum excitation of the JMA seismic intensity scale V. D scatters with small values, however Evaluated D values are proportional to Observed D values.

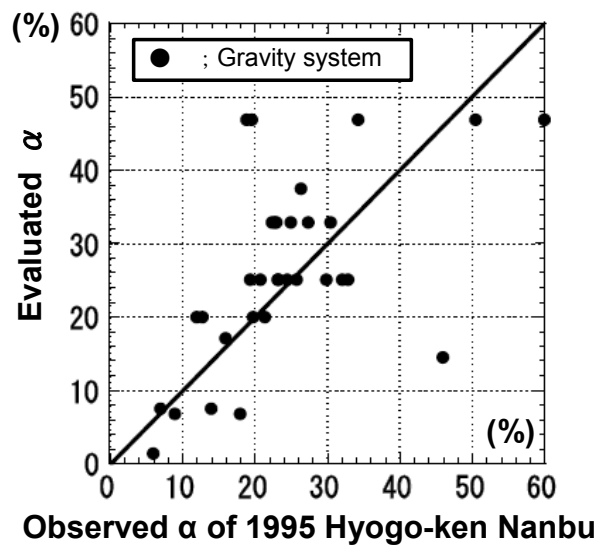
Figure 5 Comparison between Observed and Evaluated  $\alpha$

$\alpha$  values were caused by the maximum excitation of the JMA seismic intensity scale VI, where Observed D values ranged from 1.5 to 6.0 meters. Evaluated  $\alpha$  values have good agreement with Observed D values. It has been assured that proposed a simple evaluation method in this study has appropriate accuracy for picking up the weak quay walls with less seismic performance.

Figure 5 presents comparison of  $\alpha$  value between Observed one of 1995 Hyogo-ken Nanbu earthquake and Evaluated one.
