FAULT RUPTURE AND KINEMATIC DISTRESS OF EARTH FILLED EMBANKMENTS

V. Zania¹, Y. Tsompanakis² and P.N. Psarropoulos³

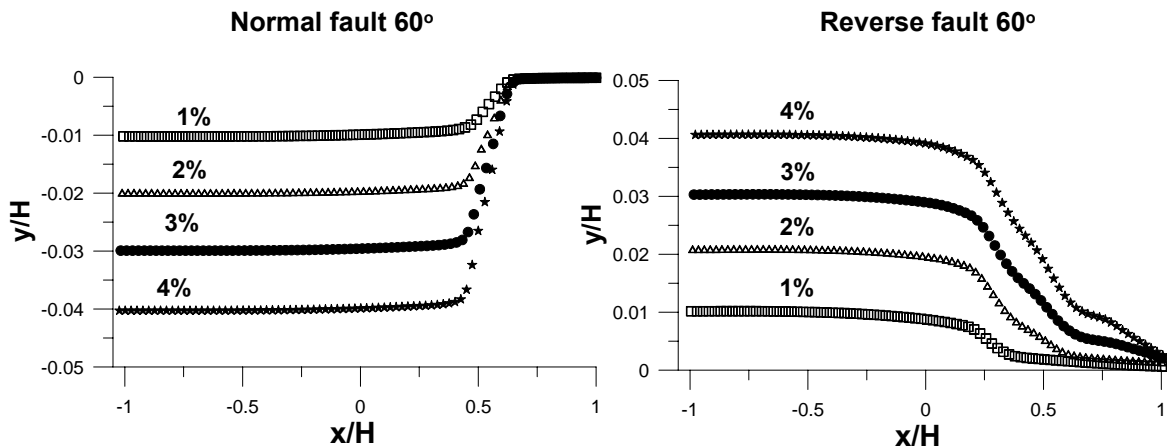
Figure 6 Fault tip at point A: Variation of the normalized to the height of the embankment vertical displacement of the surface relatively to the normalized to the height of the embankment deformed horizontal coordinate. Results are presented for four levels of relative displacement (δ/R): 1%, 2%, 3%, and 4%.

Subsequently, the cases of a normal and a reverse fault with dip angle equal to 60° and a fault with angle equal to 90° were analyzed at the same positions A and B. The results of the aforementioned cases are depicted in Figures 6 and 7. It is obvious that a secondary failure surface, and therefore a graben, is not formed as an outcome of the normal fault propagation possibly due to the higher dip angle of the fault. Additionally, the surface exposure of the fault is observed at a distance almost equal to $0.5H$, where the direct projection of the fault plane would be expected. The zone of surface deformation is relatively narrow extending from $0.5H$ to $0.75H$. On the other hand, the fault of dip angle equal to 90° propagates almost vertically, thus, the surface deformations are concentrated at the axis of symmetry of the embankment for all the computed levels of relative displacement. The width of the developed zone of deformation during the propagation of the reverse fault increases as the fault dislocation increases. Initially, for small magnitude of fault displacement ($\delta/H=1\%$) the surface exposure of the fault is located at a distance equal to $0.25H$ from the fault tip, indicating an angle of fault rupture propagation equal to 75° . The increase of the fault displacement to $\delta/H=4\%$ is related to a zone of surface deformation extending from $0.25H$ to the crest of the embankment, indicating the decrease of the angle

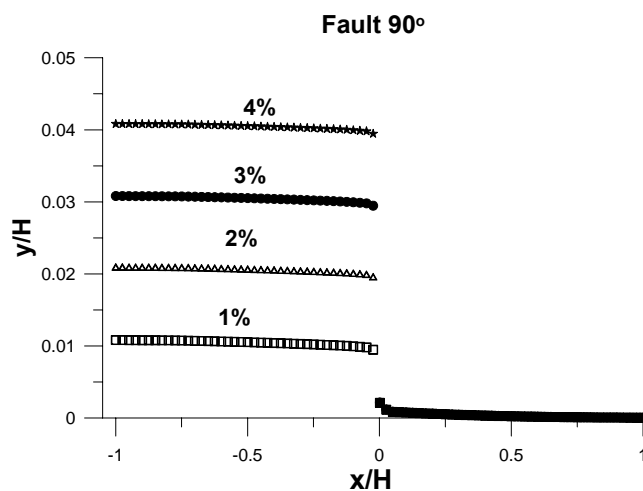
Figure 7 Fault tip at point A: Variation of the normalized to the height of the embankment vertical displacement of the surface relatively to the normalized to the height of the embankment deformed horizontal coordinate.

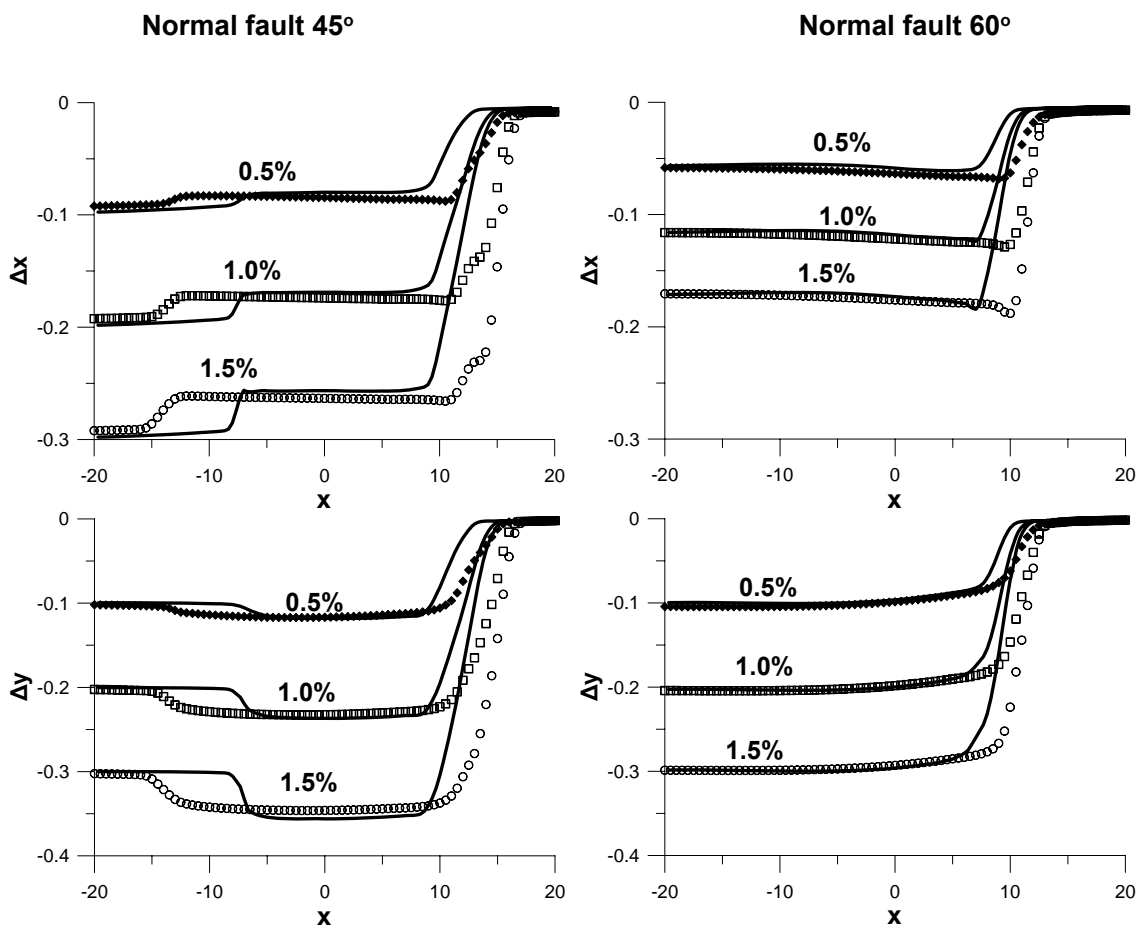
Figure 8 Fault tip at point B: Variation of the horizontal and vertical displacement of the surface relatively to the horizontal component of the distance from the fault tip. Results are presented for dip angle equal to: (a) 45° and (b) 60° . The symbols represent the corresponding results for fault tip at point A.

Results are presented for four levels of relative displacement (δ/R): 1%, 2%, 3%, and 4%. Furthermore, the case of the fault tip located under the slopes of the embankment is investigated. For this purpose the propagation of a normal fault with dip angle equal to 45° and 60° and fault tip located at point B are analyzed. Results of the aforementioned cases are presented in Figure 8 in terms of horizontal and vertical displacement with respect to the horizontal component of the distance from the fault tip ($x=0\text{m}$). Note that due to the geometry of the embankment the fault crest is located at $x=20\text{m}$. In the same figure the corresponding results of the analyses for location of the fault tip at point A are also shown (symbols). For the case of dip angle equal to 45° the angle of fault propagation as well as the magnitude of displacement required for surface exposure of the fault are quite similar for the two positions of the fault tip. Nevertheless, the distance at which the secondary failure surface is observed is not comparable for the two examined positions, possibly due to the inclined surface of the slopes of the embankment. Additionally, in both examined cases the width of the zone of deformations and the magnitude of plastic deformations are increased when the fault tip is located under the slope of the embankment (point B).
