## Retrofitting House Foundations to Resist Earthquakes; Justification, Benefits and Costs

G.C. Thomas<sup>1</sup> and J.D. Irvine<sup>2</sup>

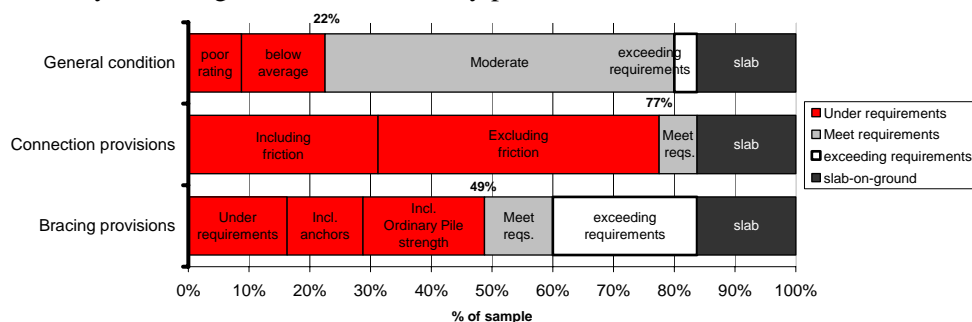
Figure 2 Overall failure for key foundation elements

Overall, an average of 49% of foundations, were below acceptable requirements for all key elements of foundation adequacy. As shown in Figure 2, 16% of sample dwellings had little or no bracing and a further 33% used non-prescribed methods such as chimney bases and concrete porches, to provide bracing potential. The majority of houses that failed to meet the required standards had full piled foundations that were commonly found in houses prior to the 1940's. The connections providing the load paths to the bracing members from the floor were inadequate in at least one location in 32% of dwellings. Weak connections in repiled dwellings accounted for a large proportion of the sample built prior to 1940, usually occurring between the ordinary pile to bearer connections.

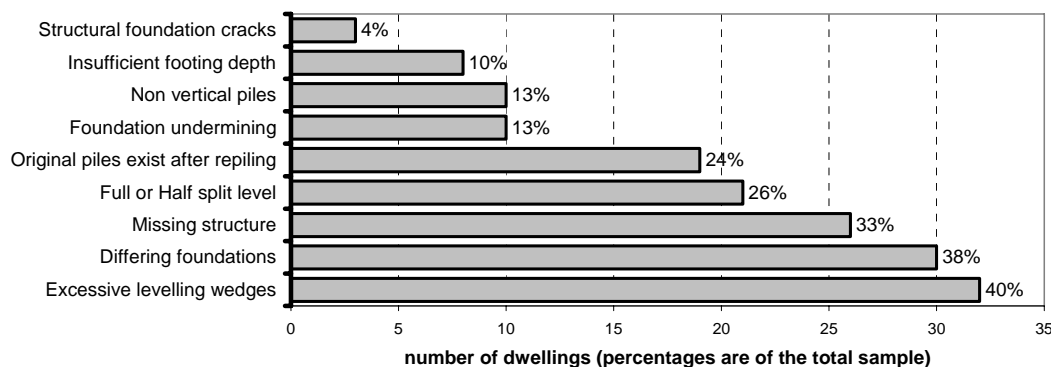
Figure 3. General conditions pertaining to foundation durability

The general conditions observed onsite correlated well with the 2005 BRANZ House Condition Survey (Clark et al., 2005), however more deficiencies such as excessive levelling wedges in repiled and re-levelled dwellings were observed in the sample. Figure 3 shows the percentage of the sample with general condition deficiencies. A number of dwellings, particularly older dwellings had a combination of these deficiencies. Dwellings that had been renovated often had full or half split-level additions usually made to the lower floor by excavating the foundations, and almost half of these dwellings had differing foundations likely to cause serious configuration issues under lateral loading.
