SEISMIC EVALUATION OF WOOD HOUSE OVER GARAGE

ABSTRACT: This study presents results from shake table and pseudo-dynamic tests of a wood building conducted at the University of California, Berkeley. A 13.5-ft×19.5-ft two-story wood building representing San Francisco 1940's design of residential house with a garage space on the first story (house-over-garage) was tested. The test building was subjected to scaled ground motion from Loma Prieta 1989 earthquake scaled to match design spectra of a site in Richmond district of San Francisco. The test results from conventional instrumentation and high-definition laser scanning techniques demonstrated the seismic vulnerability of the test building due to soft story mechanism and significant twisting when shaken in two horizontal directions. A brief discussion of pseudo-dynamic testing conducted on a substructure from the first story of the building is presented with comparison between the findings from the pseudo-dynamic and shake table tests.

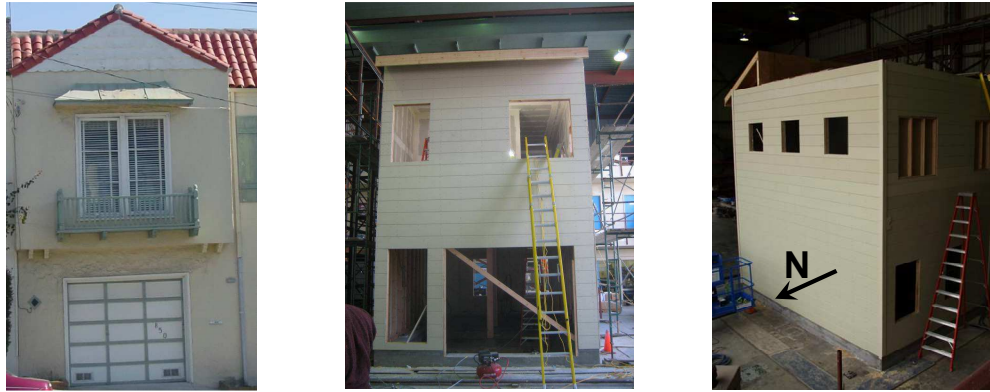
a) House in San Francisco b) Test building – east c) Test building – northwest
 Figure 1 Similarity between a typical San Francisco house and the test building

The test building is a hypothetical two-story single-family "house-over-garage" representing the plethora of houses in San Francisco, California constructed in 1940's, Figure 1a. Due to the size of the shake table, the constructed plan dimensions of the test building were limited to 19' 6"×13' 6". The total height was 18' 6" and roof partially covered by a parapet of height 2' 10", Figures 1 and 2. Several configurations with various levels of retrofitting of the building were tested. This paper focuses on the performance of the as-built structure. The second story comprised the living space where the floor was divided into three rooms and one corridor by two partitions walls attached to the south solid wall. Second story walls and ceiling were internally covered by gypsum boards. Siding consisted of ship laps connected to the frame by three 8d common nails per stud crossing. No exterior finishes were applied consistent with the 1940's construction techniques. A summary of the used material for the

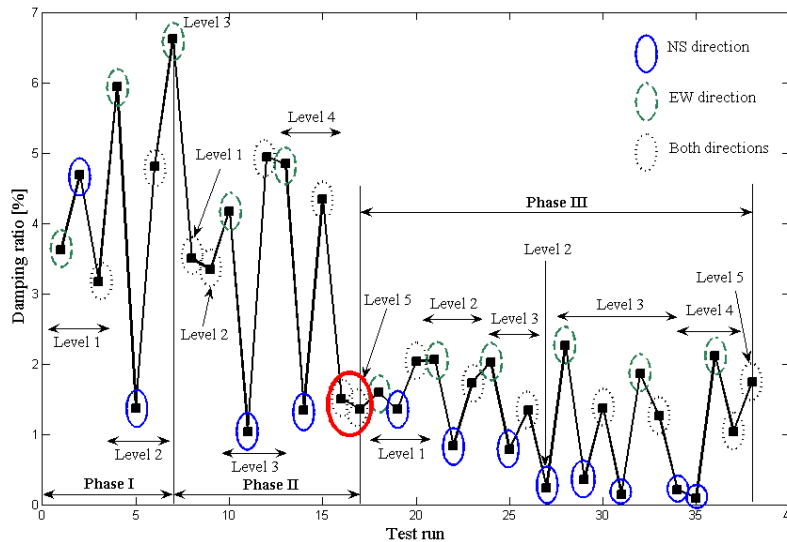
Figure 3 Variation of the energy equivalent mean damping ratio in the EW (longitudinal) direction

obtained from the hysteretic plot of the lateral displacement of the first floor versus the base shear of the building, Figure 3 summarizes the findings. One distinguishes two average values of the damping ratio, before (5% as used in HS [2]) and after severe shaking (2%), i.e. level 5 in runs 16 and 17. This reduction in the damping ratio is attributed to less energy dissipative mechanisms after the building experienced major damage with increased tendency to twist after runs 16 and 17. The largest damping ratio of 6.62% (~13% less than value in Table 3) was estimated at run 7. Finally, the damping ratios for the same input level were significantly higher (up to 10 times) in the EW than the NS due to limited energy dissipation mechanisms in the NS direction.

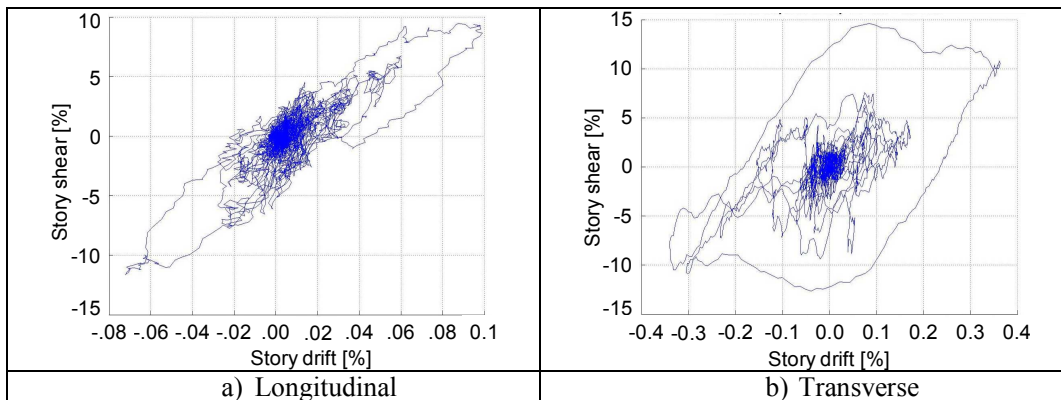
Figure 5 Force-deformation relationships of second story for run 33

The second story experienced much less damage than the first story, remaining essentially elastic in the longitudinal direction, Figure 5a. The transverse direction in the second story experienced significant reduction of the average (between east and west walls) secant stiffness, Figure 5b, due to accumulation of damage in the junction between the first and second stories. For the transverse direction, the secant stiffness values, Table 4, are based on peak-to-peak story shear (initial) and on peak-to-peak story drift (final) with 7.08 reduction factor.

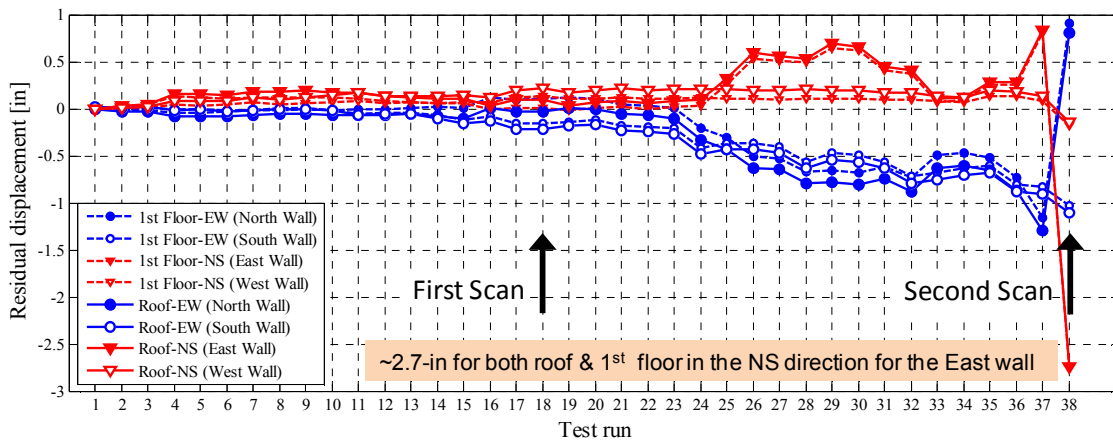
Figure 6 Variation of the residual displacements for different shake table runs using conventional measurements

The accumulation of the permanent deformations of the test building from all test runs is given in Figure 6 by subtracting the mean of the first 0.5 sec of the data from that of the last 0.5 sec. The difference between the residual displacements in the same direction at different walls is indicative of the residual twist in the test building. The runs after which the laser scans were performed are indicated on Figure 6.

Four scans were conducted with a variety of locations and details. Complete discussion of the global and local results obtained from these laser scans can be found in [5]. High definition laser scanning targets are necessary for referencing and stitching scans to combine them into one image. Correctly selected targets are valuable for creating a consistent coordinate system for studying ‘before’ and ‘after’ conditions of test structures. Figure 7b reflects the permanent (residual) deformation in the out-of-plane direction of the north longitudinal wall, Figure 7a. Several slices in the horizontal and vertical directions of the building’s point cloud were investigated. The horizontal slices were taken at the ceiling elevations of the first and second story. One vertical slice was taken one foot to the west of the east wall. The horizontal slices showed the twist of first floor and roof dictated by the asymmetric plan of the test building. Figure 8 presents the point clouds before and after testing along the height of the test building for the vertical slice showing the soft story mechanism due to the garage opening in the east wall of the first story. The average residual deformation in the transverse direction were about 2.7" from the south and north sides. This result is consistent with the findings from Figure 6 using the conventional measurements.

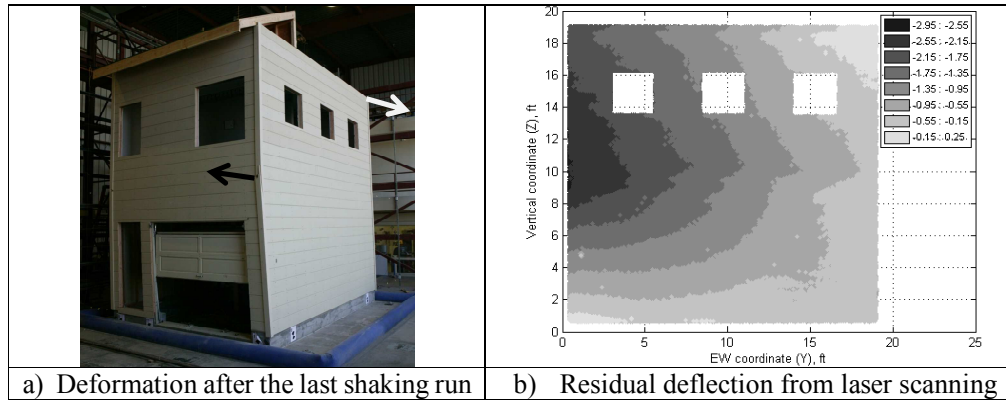
Figure 7 Out-of-plane deformation of the north longitudinal wall

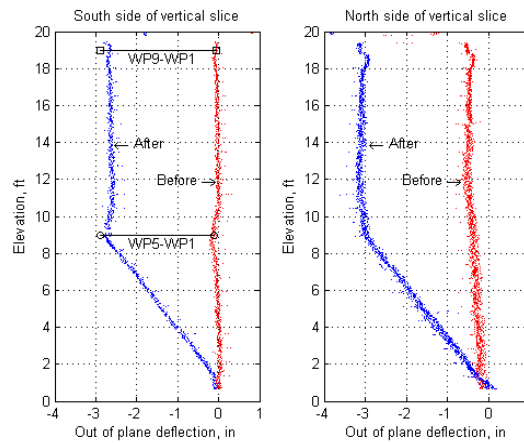
Figure 8 Residual north-south deflections of east wall sides (view from east)
