SEISMIC TESTING OF A FULL-SCALE WOOD STRUCTURE ON TWO SHAKE TABLES

I.P. Christovasilis,¹ A. Filiatrault² and A. Wanitkorkul³

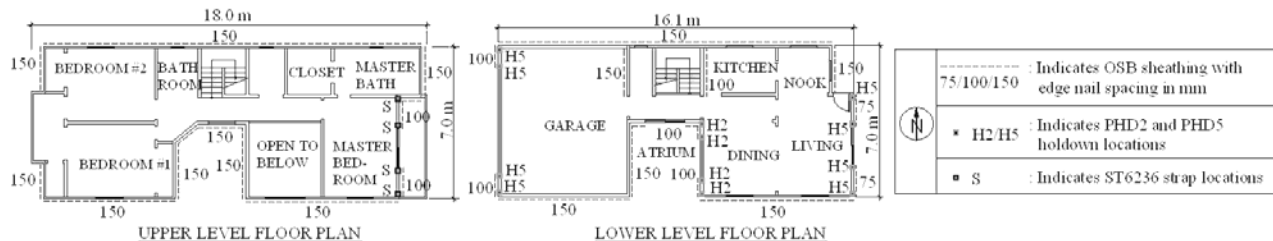
Figure 1. Plan views of test building.

The twin re-locatable, 50-ton, tri-axial shake tables of the Structural Engineering and Earthquake Simulation Laboratory (SEESL) at the University at Buffalo (UB) were utilized for the experiment. The two tables acting in unison were required to accommodate the size and weight of the full-scale test building. The 7 m x 7 m extension steel frames available on both of the UB-SEESL shake tables were connected together by a steel link structure to support the entire woodframe structure across the two shake tables with minimal vertical deflection. Threaded A-307 steel rods bolted to the existing extension frames were used as anchor bolts for the sill plates. A 60-mm thick layer of grout was installed on top of the steel base beneath the pressure treated sill plates to simulate the friction of the sill plate against a concrete foundation. Seismic holdowns were installed at the end of various first level narrow wall piers, as shown in Figure 1.

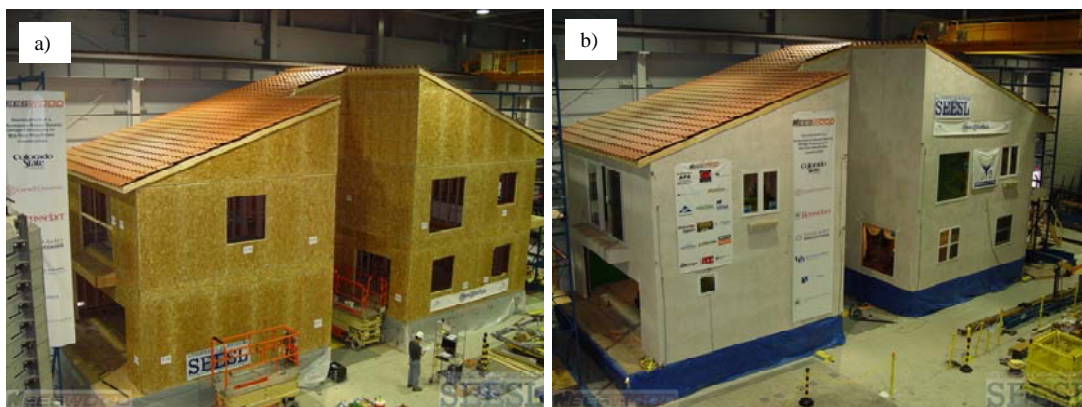
Figure 2. Test building on shake tables: (a) without wall finishes –Phase 1, and (b) with wall finishes –Phase 5.

Multiple seismic tests were conducted for various configurations of the test building. Table 1 presents a summary of the five seismic test phases included in the test program and the corresponding configurations of the test building. Low amplitude white noise tests were also conducted between the seismic tests of each phase to determine the changes in the dynamic characteristics (natural periods, mode shapes and damping) of the test building as it experienced increasing levels of damage during each test phase. The building was repaired after each test phase to return the lateral load-resisting system to its original characteristics before the start of each subsequent test phase. These repairs included replacing some of the OSB panels, gypsum wallboards and wood studs. Note that all test phases were performed for a constant mass of the test building by incorporating ballast weights at the floor level for the test phases in which some of the wall finish materials were omitted. In this paper, only Phases 1, 3, 4 and 5 are discussed. Information on Test Phase 2, incorporating fluid dampers in selected locations of the test building, is available in Shinde et al. (2007). Test Phases 1, 3, 4 and 5 were designed to evaluate the effect of interior and exterior wall finishes on the seismic response of the test building. In Phase 1, the test building incorporated only the wood structural members without any wall finishes. In Phase 3, 12-mm thick gypsum wallboards were applied to the interior surfaces of the structural perimeter walls and to both sides of the two interior structural shear walls, located at the first level of the test building in the North-South direction (see Fig. 1). In Phase 4, gypsum wallboards were also applied to all interior partition walls and ceilings. Finally, in Phase 5, 3-coat, 22-mm thick, stucco was applied to the exterior walls. Figure 2 shows photographs of the Phase 1 and Phase 5 test building ready for testing on the shake tables.

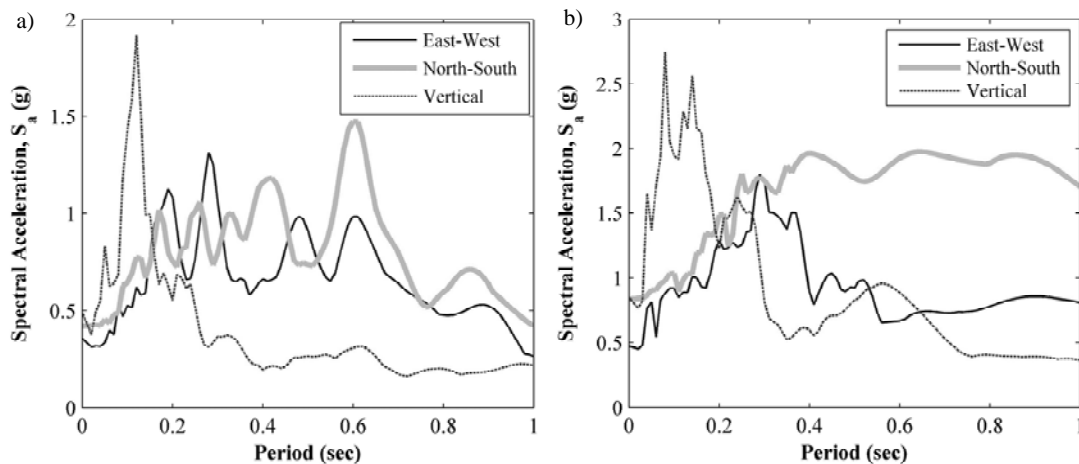
Figure 3. Absolute acceleration response spectra at 5% damping of earthquake ground motions used in seismic tests (a) Canoga Park Record, and (b) Rinaldi Record.

Two different types of tri-axial historical ground motions were used for the seismic tests: ordinary ground motions and near-field ground motions. The ordinary ground motions represented a Design Earthquake (DE) having a probability of exceedance of 10% in 50 years (10%/50 years), or equivalently, a return period of 475 years. The 1994 Northridge Earthquake ground motions recorded at Canoga Park, with an amplitude scaling factor of 1.20, were selected as the DE (Krawinkler et al. 2000). The near-field ground motions represented a Maximum Credible Earthquake (MCE) having a probability of exceedance of 2% in 50 years (2%/50 years), or a return period of 2475 years. The unscaled 1994 Northridge Earthquake ground motions recorded at Rinaldi were selected as the MCE (Krawinkler et al. 2000). Figure 3 presents the absolute acceleration response spectra at 5% damping for these two (unscaled) tri-axial seismic records.

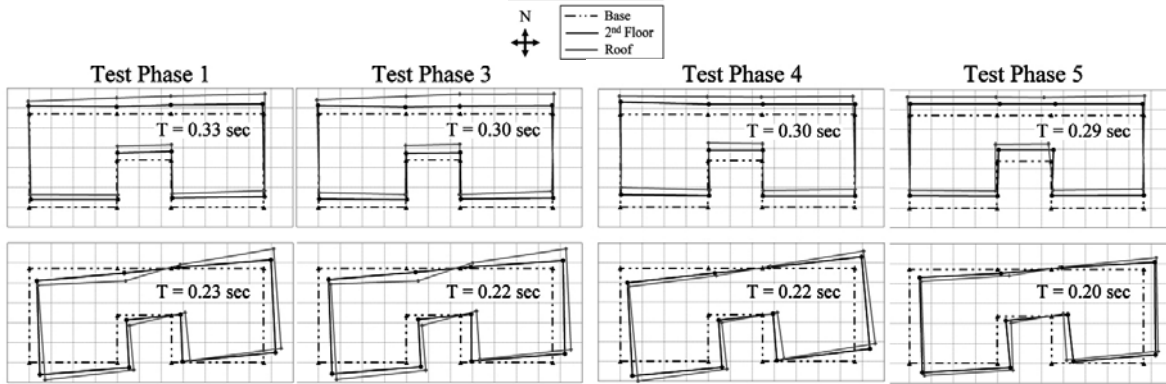
Figure 4. Initial natural periods and mode shapes of test building

Figure 4 shows the initial fundamental periods and mode shapes in each principal direction of the test building before the beginning of Test Phases 1, 3, 4 and 5, respectively. Not surprisingly, the fundamental periods of the test building are significantly longer in its transverse (North-South) direction than in its longitudinal (East-West) direction. The introduction of gypsum wallboard finishes on the structural walls in Test Phase 3 causes a reduction in the fundamental period of 9% and 5% along the transverse and longitudinal directions of the test building,

respectively. These results indicate that introducing gypsum wallboard finishes on the interior surfaces of the structural walls increased the lateral stiffness of the test building. On the other hand, the introduction of similar gypsum wallboard finishes to all the interior partition walls and ceilings in Test Phase 4 had no effect on the fundamental periods and, thereby, the lateral stiffness of the test building (at least at low levels of shaking). This lack of positive effect can be attributed to the lack of structural connections between the interior partition walls and the floor and roof diaphragms of the test building.

The introduction of stucco on the exterior walls of the test building in Phase 5 causes a reduction in the fundamental period of 3% and 9% along the transverse and longitudinal direction of the test building compared to the Phase 4 configuration. In terms of equivalent lateral stiffness, Phase 5 exhibits an increase in lateral stiffness of 29% and 32% along the transverse and longitudinal directions, respectively, compared to the original Phase 1 building. For both directions, the deformations are concentrated in the first level of the test building, indicating the potential for a weak first story collapse mechanism. The fundamental mode shapes in the longitudinal direction are also affected by torsional response and by the in-plane shear deformations of the floor diaphragm in the stair core area between the two main units of the townhouse, particularly for the Phases 1 and 3. For Phases 4 and 5, the shear deformations of the diaphragm are reduced because of the in-plane stiffness provided by the gypsum ceilings.

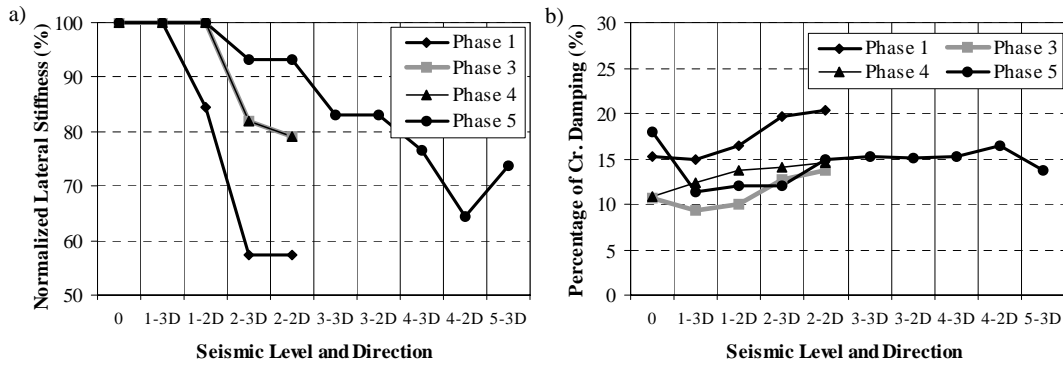
Figure 5. (a) Variations of normalized lateral stiffness in North-South direction of test building, and (b) Variations of first modal damping ratios in North-South direction of test building.

Figure 5a illustrates the deterioration of the equivalent lateral stiffness in the transverse (North-South) direction of the test building through the various seismic tests conducted, assuming a single-degree-of-freedom response of the test building. Since the initial fundamental period is known, as well as the fundamental period measured after each seismic test, the normalized equivalent lateral stiffness, after each seismic test, can be calculated as a percentage of the initial lateral stiffness. The deterioration of the lateral stiffness is more pronounced for the Test Phase 1 configuration. The stiffness at the end of this phase dropped to less than 60% of the initial stiffness after Test Level 2. The lateral stiffness for the structures of Test Phases 3 and 4 was above 80% of their initial stiffness after Level 2 test; the corresponding value for the Test Phase 5 structure was above 90%. Even after the tri-axial DE Seismic Level 4 test, the lateral stiffness of the Test Phase 5 structure remained above 75% of its initial lateral stiffness. The deterioration was smaller when wall finishes were applied for the same level of simulated ground shaking. Note that the increase of the stiffness that is observed after the final tri-axial test of Seismic Level 5 of Test Phase 5 was due to the repair of damaged anchor bolts in the two walls on the West (garage wall) and East side of the first floor of the benchmark structure, prior to the execution of the Level 5 tri-axial test, which resulted in a stiffer structure. Figure 5b shows the variations of the first modal equivalent viscous damping ratio measured in the North-South direction of the test building after each seismic test conducted. The first modal damping ratios range from 10 to 20% of critical, with a mean value of around 15% of critical for all test phases.

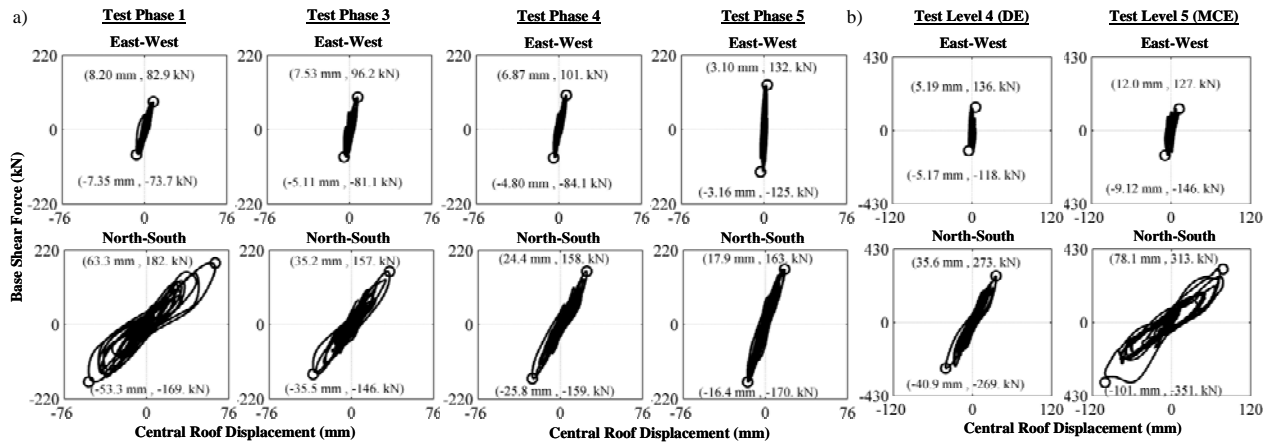
Figure 6. Global hysteretic responses of test building, (a) Test Level 2, and (b) Test Phase 5

Figure 6a shows the global hysteretic responses (base shear force vs relative horizontal displacement at the center of the roof eave level) of the test building during Test Phases 1, 3, 4 and 5, respectively and under Seismic Test Level 2. The base shear was computed by summing the inertia forces at each level of the test building based on horizontal acceleration recordings. The maximum base shear and displacement achieved in each direction are indicated by circles on each graph. As expected, the lateral displacements in the transverse (North-South) direction are significantly larger than those in the longitudinal (East-West) direction. In Test Phase 1, the wood-only building experienced a peak roof displacement of 63 mm (1.3% building drift) in its transverse direction under the Seismic Test Level 2 representing excitation intensity of 44% of that expected for the Level 4 Design Earthquake (DE). The introduction of gypsum wallboard finishes on the structural walls in Test Phase 3 resulted in a significant reduction in transverse roof displacements (approximately 44% reduction compared to the wood-only building of Phase 1). The overall hysteretic response of the building in Test Phase 3 is also stiffer than that of Test Phase 1, indicating the important effects that the gypsum wallboard had in stiffening the structural walls. The introduction of gypsum wallboard on the interior partition walls and ceilings in Test Phase 4 resulted in a further reduction of 29% in roof displacements in the transverse direction (35 mm in Phase 3 vs 24 mm in Phase 4). Finally, the introduction of stucco on the exterior walls reduced the roof displacements even further to 18 mm; similar results are observed in the longitudinal direction. Note in Fig. 6a that only moderate pinching is observed

for the transverse (North-South) direction in the wood-only Test Phase 1 building, while almost linear elastic responses are observed for Test Phases 3, 4 and 5. This result indicates that the wall finishes not only reduced the displacement response of the test building but changed also its overall hysteretic characteristics. Figure 6b shows the global hysteretic responses obtained with the complete (Phase 5) building under Test Levels 4 (DE) and 5 (MCE), respectively. In the transverse (North-South) direction, the maximum roof displacement reached 41 mm (0.8% drift) under the DE level and 101 mm (1.9% drift) under the MCE level. Note that the wood-only building of Phase 1 exhibited, under Test Level 2, a peak roof displacement larger than the Phase 5 building under the DE Test Level 4.

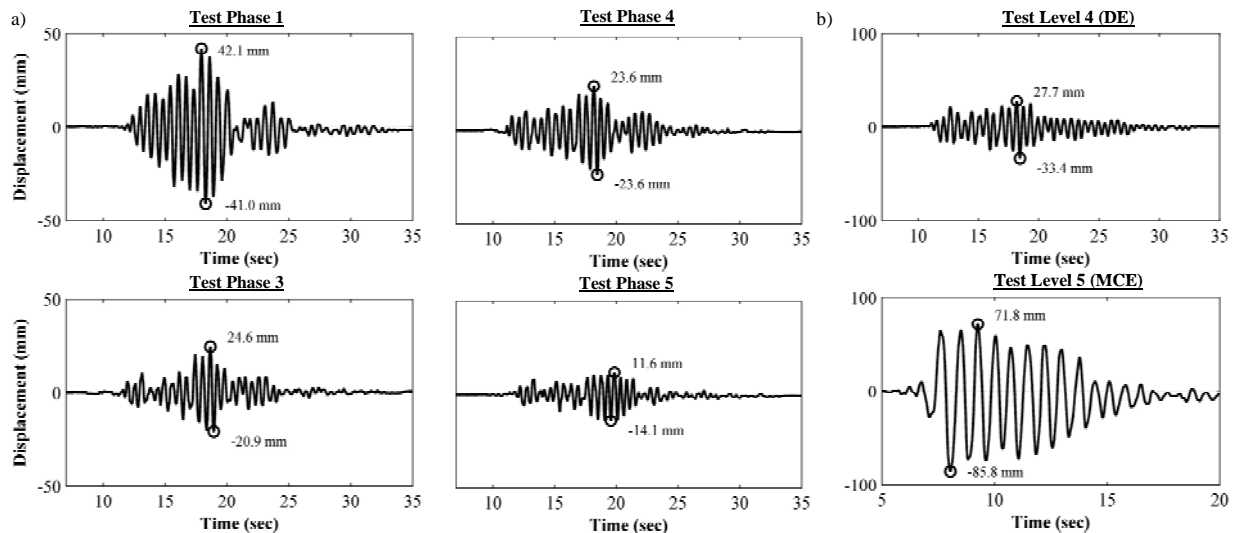
Figure 7. Response of garage wall line, (a) Test Level 2, and (b) Test Phase 5

Figure 7a shows the inter-story drift time-histories measured along the garage wall line during Test Phases 1, 3, 4, and 5, respectively and under Seismic Test Level 2. The garage wall line of the wood-only building of Phase 1 experiences a peak relative displacement of 42 mm (1.5% inter-story drift) which corresponds to 65% of the total building drift developed in the transverse direction during this test (see Fig. 6a). This result indicates that most of the transverse lateral displacements of the test building in the garage wall line occurred at the first level, which suggests a possible soft-story collapse mechanism under higher amplitude base excitations. Note that this conclusion is valid for the garage wall line only under high level of excitations. For some other wall lines in the building, the second story inter-story drifts could be greater than the first story in some cases under lower amplitude excitation. Again, the introduction of gypsum wallboard finishes on the structural walls in Test Phase 3 caused a significant reduction in the peak drift experienced by the garage wall line (42% reduction compared to the wood-only building of Phase 1). The response of the Test Phase 4 building, however, is almost identical to that of Phase 3. This can be explained by the fact that very little interior partition wall lines were incorporated in the first level of the test building (see Fig. 1). The incorporation of exterior stucco finish also caused a significant reduction in the peak drift experienced by the garage wall line (66% reduction compared to the wood-only building of Phase 1 and 42% reduction compared to the Phase 3 building).

Figure 7b shows the inter-story drift time-histories measured along the garage wall line of the completed Test Phase 5 building under Seismic Test Levels 4 (DE) and 5 (MCE), respectively. The Test Phase 5 building experienced peak relative displacements at the garage wall line of 33 mm (1.2% inter-story drift) and 86 mm (3.1% inter-story drift) under the DE and MCE levels, respectively. Note again that the wood-only Phase 1 building experienced higher drifts at the garage wall line under Test Level 2 (44% DE) than the complete Test Phase 5 building under Test Level 4 (100% DE). This result again underscores the significant contribution of the wall finishes in improving the seismic response of the test building.
