## LESSONS LEARNT FROM SHELTER ACTIONS AND RECONSTRUCTION OF BAM AFTER THE DESTRUCTIVE EARTHQUAKE OF DECEMBER 26, 2003

### ABSTRACT:

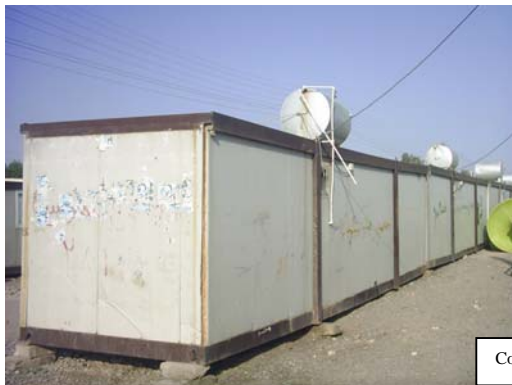
The aftershocks did not have a significant affect on shelter policies and provision after the disaster. People were reluctant to live in masonry houses, because of the pressure they had experienced in the disaster and the high likelihood of being killed in such buildings. Other hazards also were not taken into consideration, however, the temporary shelters were mostly strong enough for the aftershocks and the fire safety was considered to some extent in their initial design. The lack of pre-disaster hazard mapping resulted in an absence of vulnerability assessments and consequent action could have taken place before the event. However, after the earthquake around 2000 damaged buildings, mostly houses were inspected for their probable remaining resistance against future earthquake(s) by some consulting firms, and most of them were designated as being repairable and were strengthened to an acceptable extent. Many of the temporary shelters were strong to resist aftershocks (Figure 1).

Figure 1 Temporary shelters with high integrity

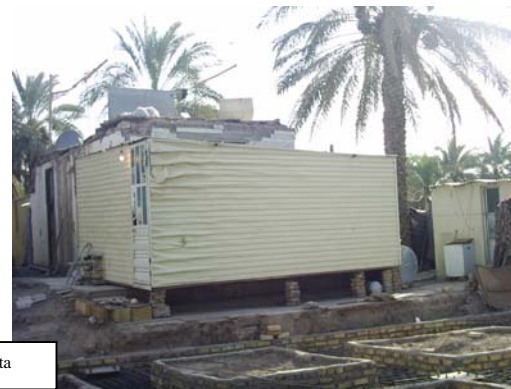
Figure 2 The wrong installation of shelter

In fact, the temporary shelters with high structural integrity could appropriately withstand aftershocks despite being set on loose stone footings, however, in many cases, lack of knowledge and supervision caused some inappropriate installation which could have been vulnerable if a major aftershock would have happened (Figure 2). In such cases the wrong installation of the shelter on rudimentary brick pedestals had placed the shelter at risk from aftershocks.

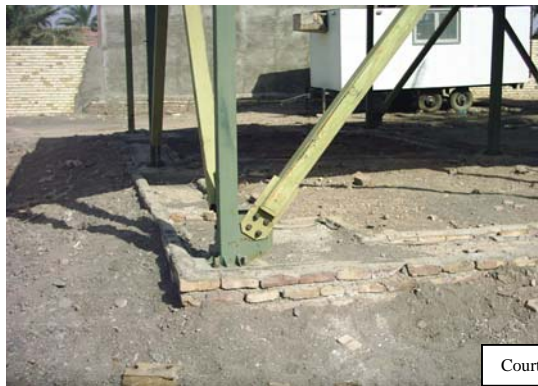
In spite of appropriate community participation it should be noted that at the first few months people were more sensitive to the resistance of their new buildings against future earthquakes, but after a while, due to the administrative problems and lack of sufficient and available technology, they had no choice other than to agree that the reconstruction situation would not get any better. Therefore, they restarted the use of masonry construction once again and used the old welding techniques in their construction. Therefore, quality control became very weak at that point. However, there were also some good reconstruction works as using bolt connections (Figure 3).

Figure 3 Use of bolt connections in steel frames

Unfortunately, this good practice was abandoned after some months due to the lack of skilled workers who could make the bolt connections, or due to the lack of proper materials. People also made the containers, provided as temporary shelters, a part of their houses within the walls around them, as can be seen in (Figure 4). It can be seen in this figure that with construction of a wall around the container, it has been accepted as a permanent part of the house. Also the low quality of masonry work of the wall is notable in (Figure 4).

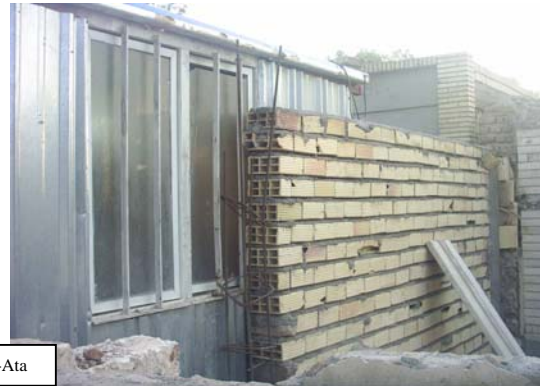
Figure 4 Using a container as a part of the house

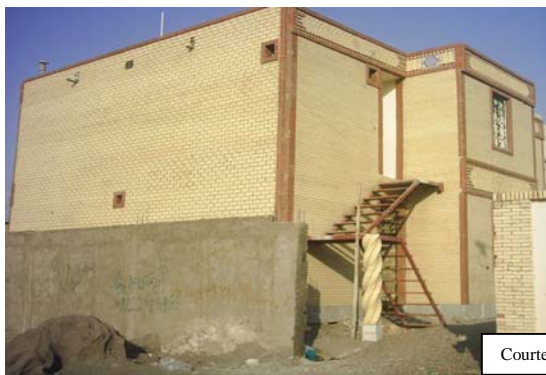
Another technical shortcoming with regard to community participation was connecting the steel stairs to the brick wall which results in a very low quality of work as shown in (Figure 5). The use of castellated beams as main girder was another weak point shown in (Figure 6), in spite of the fact that this is not allowed by the National Iranian Construction Code for steel structures.

Figure 5 Connection of steel stairs to brick wall

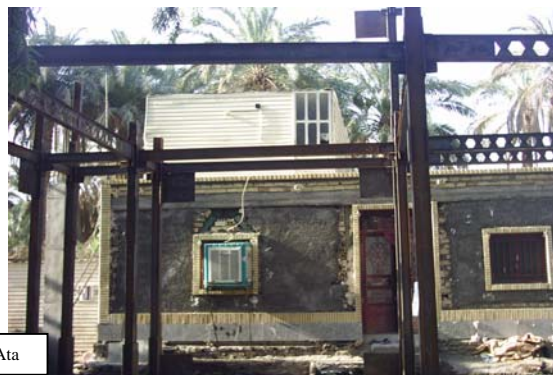
Figure 6 Use of castellated beams as main girders

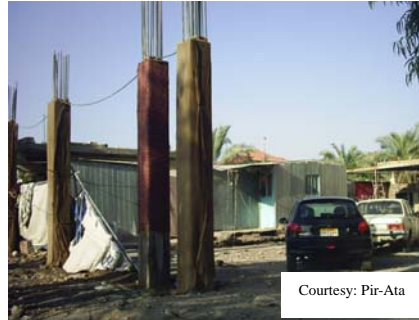
- A decrease in the observation of building codes, regulations and standards with the elapse of time after the earthquake, see (Figure 7). Buildings built earlier were constructed in a more appropriate manner according to the engineering regulations. This was seen in Lorestan 2006 earthquake as well (Izadkhah and Hosseini 2006).

Figure 7 Two columns positioned very close together indicate inappropriate structural design
